# Access Compliance Report

## Public Rights-of-Way

| Intersection ID: 54772 | Main Street: SARDIS_RD_NORTH | Cross Street: NOLLEY CT | Location: SE |
| ADA ID: FE4599BEBB56 | Ramp Type: PerpDiag | Initial Pass/Fail: Fail | Overall Compliance: No |

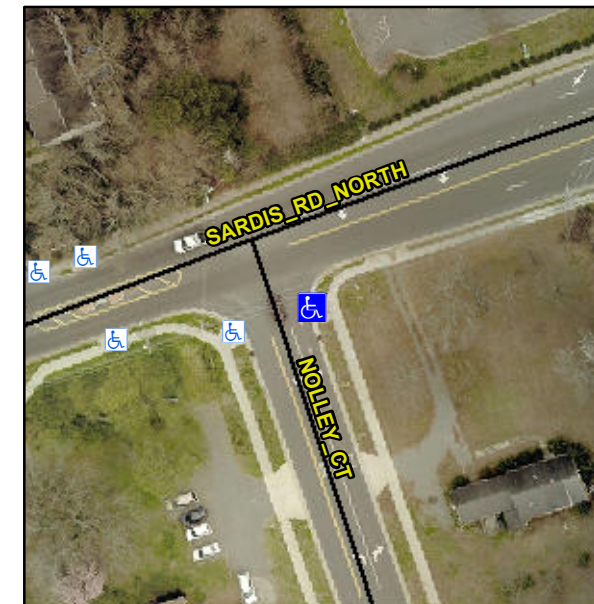
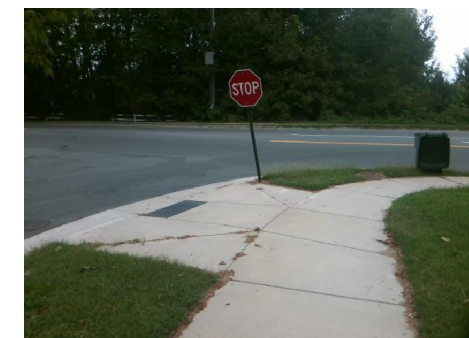
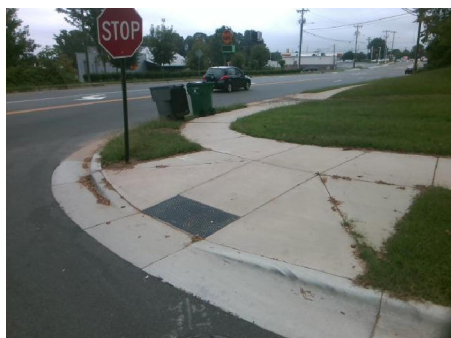
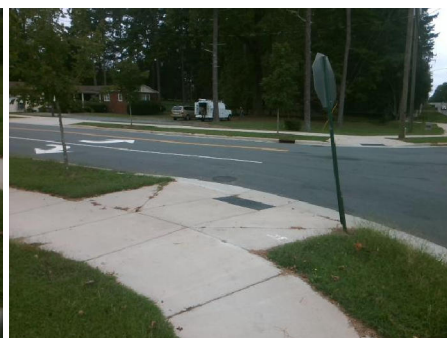
| Severity Score: 12.5 | | | |

**R304.2.2**

| Compliance | Description | Data | Compliance | Description | Data |
|---|---|---|---|---|---|
| N/A | Ramp Length (in) | 91.0 | No | Ramp Slope (%) | 9.7 |

**Remove & Replace Curb Ramp With Two New Directional Ramps or Equivalent.**
