Access Compliance Report

Public Rights-of-Way

(Curb Ramps)

Intersection ID: N/A	Main Street: CRAIGWOOD_DR	Cross Street: HICKORY_GROVE_RD	Location: SW
ADA ID: FEE901B1113E	Ramp Type: Combination2Diag	Initial Pass/Fail: Fail	Overall Compliance: No
		Severity Score: 0

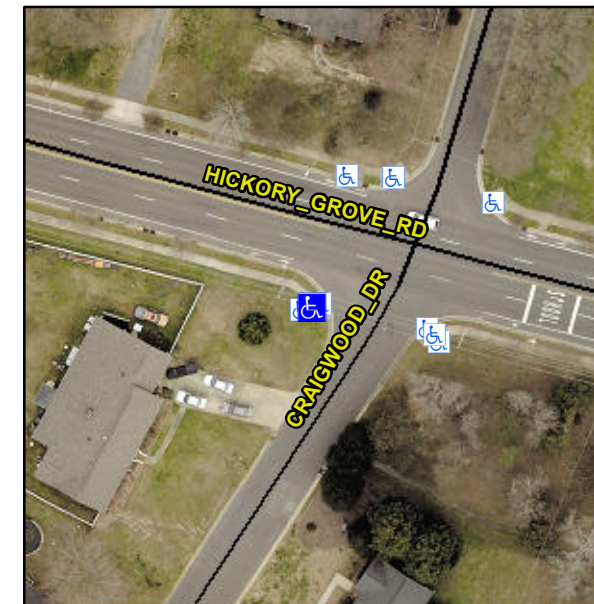
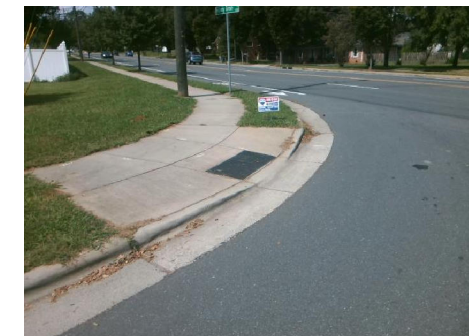
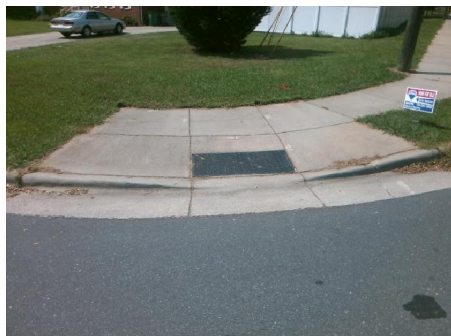
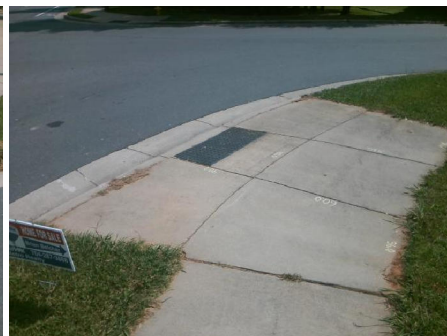
Not Found, R304.5.3, R304.3.2

Compliance	Description	Data	Compliance	Description	Data
N/A	Ramp Length LT (in)	49.0	N/A	Ramp Length RT (in)	36.0
Yes	Ramp Width LT (in)	59.5	Yes	Ramp Width RT (in)	60.0
Yes	Ramp Slope LT (%)	2.9	No	Ramp Slope RT (%)	8.9
Yes	Ramp XSlope LT (%)	1.2	Yes	Ramp XSlope RT (%)	1.6
N/A	Ramp Length (in)	48.0	Yes	Ramp Slope (%)	7.2
Yes	Ramp Width (in)	48.0	No	Ramp XSlope (%)	2.8
N/A	Flare Type LT	N/A	N/A	Flare Type RT	N/A
N/A	Flare Slope LT (%)	N/A	N/A	Flare Slope RT (%)	N/A
N/A	Flare Traversable LT?	N/A	N/A	Flare Traversable RT?	N/A
N/A	Landing Length (in)	N/A	N/A	DWS Provided?	N/A
N/A	Landing Width (in)	N/A	N/A	DWS Contrast?	N/A
N/A	Landing Slope (%)	N/A	N/A	DWS Length (in)	N/A
N/A	Landing X Slope (%)	N/A	N/A	DWS Full Width?	N/A
N/A	Landing Curb? (Y/N)	N/A	N/A	DWS Offset (in)	N/A
N/A	Shared Landing?	N/A			
N/A	Gutter Ponding?	N/A	N/A	Gutter Slope (%)	N/A
N/A	Gutter Lip Ht (in)	N/A	N/A	Gutter X Slope (%)	N/A
N/A	Painted X Walk1?	No	N/A	Painted X Walk2?	No

Remove & Replace Curb Ramp With Two New Directional Ramps or Equivalent.
