Access Compliance Report

Public Rights-of-Way

(Curb Ramps)

Intersection ID: 43581	Main Street: LUKES_DR	Cross Street: LINDA_VISTA_LN	Location:	N
ADA ID: FEFE7B3AFADD	Ramp Type: PerpDiag	Initial Pass/Fail: Fail	Overall Compliance: No	Severity Score: 35

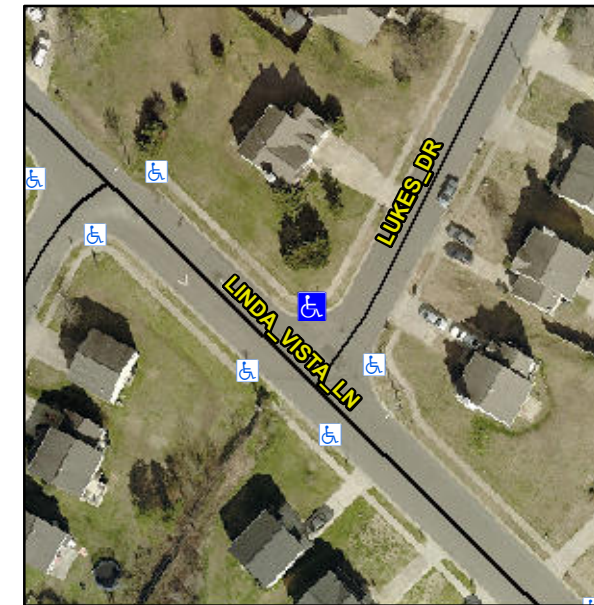
Not Found, R304.5.1

Compliance	Description	Data	Compliance	Description	Data
N/A	Ramp Length (in)	94.5	Yes	Ramp Slope (%)	8.2
No	Ramp Width (in)	30.5	Yes	Ramp XSlope (%)	1.3
N/A	Flare Type LT	N/A	N/A	Flare Type RT	N/A
N/A	Flare Slope LT (%)	N/A	N/A	Flare Slope RT (%)	N/A
N/A	Flare Traversable LT?	N/A	N/A	Flare Traversable RT?	N/A
N/A	Landing Length (in)	N/A	N/A	DWS Provided?	N/A
N/A	Landing Width (in)	N/A	N/A	DWS Contrast?	N/A
N/A	Landing Slope (%)	N/A	N/A	DWS Length (in)	N/A
N/A	Landing X Slope (%)	N/A	N/A	DWS Full Width?	N/A
N/A	Landing Curb? (Y/N)	N/A	N/A	DWS Offset (in)	N/A
N/A	Shared Landing?	N/A			
N/A	Gutter Ponding?	N/A	N/A	Gutter Slope (%)	N/A
N/A	Gutter Lip Ht (in)	N/A	N/A	Gutter X Slope (%)	N/A
N/A	Painted X Walk1?	No	N/A	Painted X Walk2?	No
	X Walk 1 Direction	To SW		X Walk 2 Direction	To SE
N/A	X Walk 1 Width (in)	N/A	N/A	X Walk 2 Width (in)	N/A
	X Walk 1 Slope (%)	8.3		X Walk 2 Slope (%)	2.6
	X Walk 1 X Slope (%)	2.0		X Walk 2 X Slope (%)	2.5

N/A	Ramp inside XWalk1?	N/A	N/A	Ramp inside XWalk2?	N/A
	Road Slope (%)	1.8	N/A	Clear Space?	N/A
	Road X Slope (%)	4.0	N/A	Clear Space to XWalk (in)	N/A
N/A	Any Obstructions?	N/A	N/A	Storm Grate/Utility Hazard?	N/A
	Obstruction Type			Storm Grate/Utility Type	
		N/A			N/A
			Yes	Surface Condition? (G/P)	Good

Remove & Replace Curb Ramp With Two New Directional Ramps or Equivalent.

Total Cost: \$ 3200.00
