Access Compliance Report

Public Rights-of-Way

(Curb Ramps)

Intersection ID: 54401	Main Street: LOMA_LINDA_LN	Cross Street: AVENAL_LN	Location: NE
ADA ID: FF424C1732EC	Ramp Type: BlendTrans1	Initial Pass/Fail: Fail	Overall Compliance: No
		Severity Score: 8.75

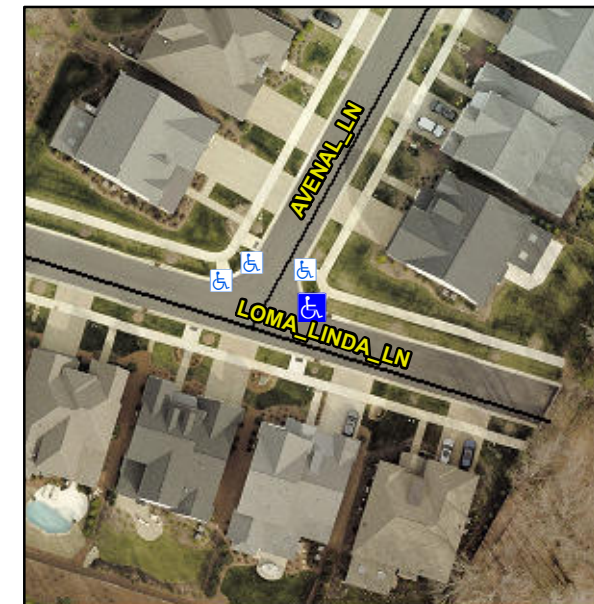
Not Found, R304.5.1

Compliance	Description	Data	Compliance	Description	Data
N/A	Ramp Length (in)	94.5	Yes	BlendTrans Slope (%)	4.2
No	Ramp Width (in)	47.0	Yes	BlendTrans XSlope (%)	0.9
N/A	Flare Type LT	N/A	N/A	Flare Type RT	N/A
N/A	Flare Slope LT (%)	N/A	N/A	Flare Slope RT (%)	N/A
N/A	Flare Traversable LT?	N/A	N/A	Flare Traversable RT?	N/A
N/A	Landing Length (in)	N/A	N/A	DWS Provided?	N/A
N/A	Landing Width (in)	N/A	N/A	DWS Contrast?	N/A
N/A	Landing Slope (%)	N/A	N/A	DWS Length (in)	N/A
N/A	Landing X Slope (%)	N/A	N/A	DWS Full Width?	N/A
N/A	Landing Curb? (Y/N)	N/A	N/A	DWS Offset (in)	N/A
N/A	Shared Landing?	N/A			
N/A	Gutter Ponding?	N/A	N/A	Gutter Slope (%)	N/A
N/A	Gutter Lip Ht (in)	N/A	N/A	Gutter X Slope (%)	N/A
N/A	Painted X Walk1?	No	N/A	Painted X Walk2?	N/A
	X Walk 1 Direction	To S		X Walk 2 Direction	N/A
	X Walk 1 Width (in)	N/A		X Walk 2 Width (in)	N/A
	X Walk 1 Slope (%)	6.1		X Walk 2 Slope (%)	N/A
	X Walk 1 X Slope (%)	0.0		X Walk 2 X Slope (%)	N/A

N/A	Ramp inside XWalk1?	N/A	N/A	Ramp inside XWalk2?	N/A
	Road Slope (%)	0.0		Clear Space?	N/A
	Road X Slope (%)	6.1	N/A	Clear Space to XWalk (in)	N/A
N/A	Any Obstructions?	N/A	N/A	Storm Grate/Utility Hazard?	N/A
	Obstruction Type			Storm Grate/Utility Type	
		N/A			N/A
			Yes	Surface Condition? (G/P)	Good
			No	Curb Slope (%)	17.1

Remove & Replace Curb Ramp With Two New Directional Ramps or Equivalent.
