Access Compliance Report

Public Rights-of-Way

(Curb Ramps)

Intersection ID: 13347	Main Street: MCCLINTOCK_RD	Cross Street: NANDINA_ST	Location: NW
ADA ID: FF5FD04F85E8	Ramp Type: Perp	Initial Pass/Fail: Fail	Overall Compliance: No
		Severity Score: 12.5

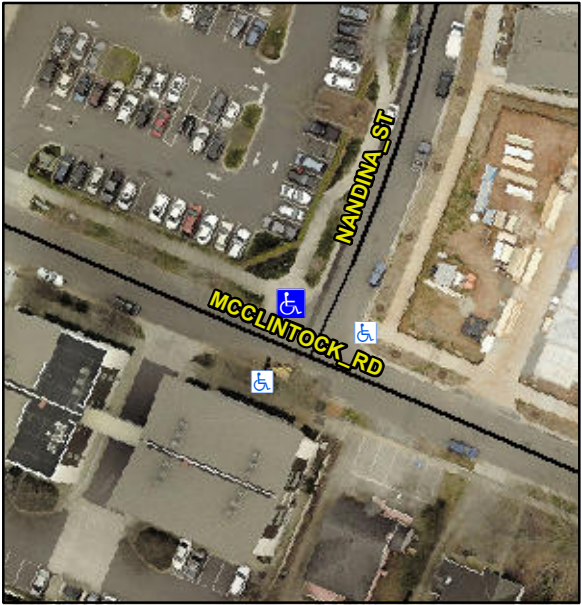
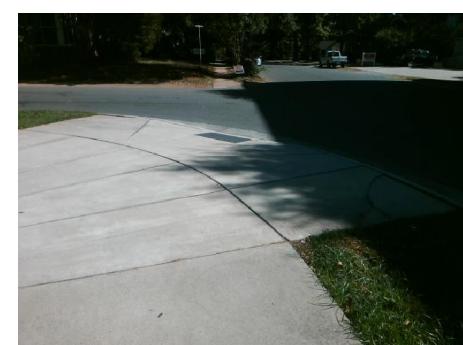
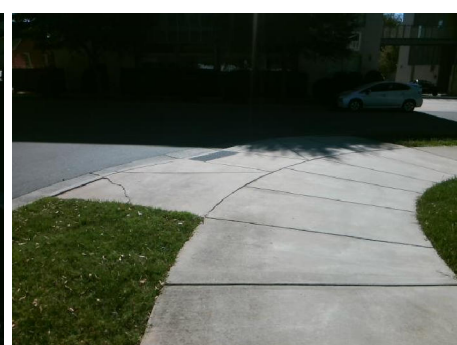
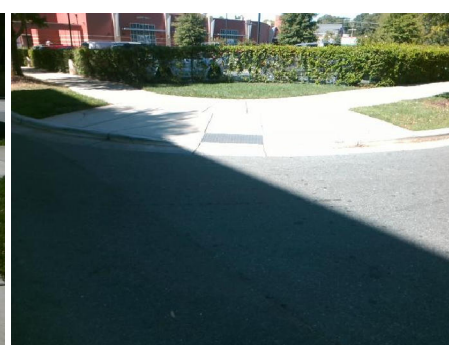
Possible Solutions:		Compliance	Description	Data
	Remove & Replace Entire Ramp.		No	Ramp Length (in)	96.0
			Yes	Ramp Width (in)	48.0
			N/A	Flare Type LT	N/A
			N/A	Flare Slope LT (%)	N/A
			N/A	Flare Traversable LT?	N/A
			N/A	Landing Length (in)	N/A
			N/A	Landing Width (in)	N/A
			N/A	Landing Slope (%)	N/A
			N/A	Landing X Slope (%)	N/A
<p>Surveyor Notes:</p> <p>N/A</p> <p>PROW/ADA:</p> <p>Not Found, R304.2.2</p>			N/A	Flare Type RT	N/A
			N/A	Flare Slope RT (%)	N/A
			N/A	Flare Traversable RT?	N/A
			N/A	DWS Provided?	N/A
			N/A	DWS Contrast?	N/A
			N/A	DWS Length (in)	N/A
			N/A	DWS Full Width?	N/A
			N/A	DWS Offset (in)	N/A
			N/A	Gutter Ponding?	N/A
			N/A	Gutter Lip Ht (in)	N/A
			No	Painted X Walk1?	N/A
				X Walk 1 Direction	To SE
			N/A	X Walk 1 Width (in)	N/A
				X Walk 1 Slope (%)	2.1
				X Walk 1 X Slope (%)	0.2

N/A	Ramp inside XWalk1?	N/A
			N/A	Road Slope (%)	N/A
			N/A	Road X Slope (%)	N/A
			N/A	Any Obstructions?	N/A
				Obstruction Type	
Total Cost: \$ 1850.00			N/A	Storm Grate/Utility Hazard?	N/A
				Storm Grate/Utility Type	
			N/A		N/A
			Yes	Surface Condition? (G/P)	Good
