Access Compliance Report Public Rights-of-Way (Curb Ramps)

Intersection ID: 15179Main Street:DRESDEN_DR_EASTCross Street:WESTCHESTER_BVLocation:SEADA ID: FF966F030BBERamp Type:PerpDiagInitial Pass/Fail:FailOverall Compliance:NoSeverity Score:10

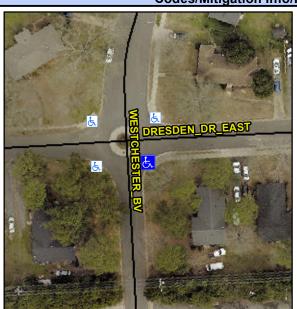
Not Found, R304.5.1, R304.5.3

Field Measurements/Component Compliance							
	Comp	Compliance Description		Compliance		Description	Data
	N/A	Ramp Length (in)	85.0	Yes	Ramp	Slope (%)	6.2
	No	Ramp Width (in)	44.0	No	Ramp	xSlope (%)	3.3
	N/A	Flare Type LT	N/A	N/A	Flare	Type RT	N/A
	N/A	Flare Slope LT (%)	N/A	N/A	Flare	Slope RT (%)	N/A
	N/A	Flare Traversable LT?	N/A	N/A	Flare	Traversable RT?	N/A
	N/A	Landing Length (in)	N/A	N/A	DWS	Provided?	N/A
	N/A	Landing Width (in)	N/A	N/A	DWS	Contrast?	N/A
	N/A	Landing Slope (%)	N/A	N/A	DWS	Length (in)	N/A
	N/A	Landing X Slope (%)	N/A	N/A	DWS	Full Width?	N/A
	N/A	Landing Curb? (Y/N)	N/A	N/A	DWS	Offset (in)	N/A
	N/A	Shared Landing?	N/A				
	N/A	Gutter Ponding?	N/A	N/A	Gutte	er Slope (%)	N/A
	N/A	Gutter Lip Ht (in)	N/A	N/A	Gutte	er X Slope (%)	N/A
	N/A	Painted X Walk1?	No	N/A	Paint	ed X Walk2?	No
		X Walk 1 Direction	To N		X Wa	lk 2 Direction	To W
	N/A	X Walk 1 Width (in)	N/A	N/A	X Wa	ılk 2 Width (in)	N/A

X Walk 1 Slope (%)	5.0		X Wa	ılk 2 Slope (%)	1.8
		X Walk 1 X Slope (%)	0.0		X Wa	ılk 2 X Slope (%)	4.7
	N/A	Ramp inside XWalk1?	N/A	N/A	Ram	p inside XWalk2?	N/A
		Road Slope (%)	2.4	N/A	Clear	Space?	N/A
		Road X Slope (%)	4.3	N/A	Clear	Space to XWalk (in)	N/A
	N/A	Any Obstructions?	N/A	N/A	Storn	n Grate/Utility Hazard?	N/A
		Obstruction Type			Storn	n Grate/Utility Type	
			N/A				N/A
				Yes	Surfa	ice Condition? (G/P)	Good
			,	•		, ,

Remove & Replace Curb Ramp With Two New Directional Ramps or Equivalent.
