Access Compliance Report

Public Rights-of-Way

(Curb Ramps)

Intersection ID: 14690	Main Street: LINGANORE_PL	Cross Street: ROMANY_RD	Location: NW
ADA ID: FFF5CD4A77DC	Ramp Type: PerpDiag	Initial Pass/Fail: Fail	Overall Compliance: No
			Severity Score: 13.75

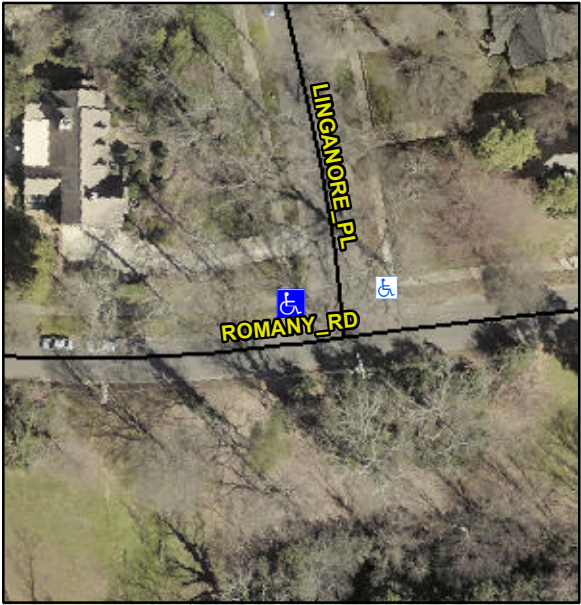
Possible Solutions:		Compliance	Description	Data
	Remove & Replace Curb Ramp With Two New Directional Ramps or Equivalent.		Compliance	Description	Data
			N/A	Ramp Length (in)	59.0
			Yes	Ramp Width (in)	70.0
			N/A	Flare Type LT	N/A
			N/A	Flare Slope LT (%)	N/A
			N/A	Flare Traversable LT?	N/A
			N/A	Landing Length (in)	N/A
			N/A	Landing Width (in)	N/A
			N/A	Landing Slope (%)	N/A
			N/A	Landing X Slope (%)	N/A
			N/A	Landing Curb? (Y/N)	N/A
			N/A	Shared Landing?	N/A
			N/A	Gutter Ponding?	N/A
			N/A	Gutter Lip Ht (in)	N/A
			N/A	Painted X Walk1?	No
				X Walk 1 Direction	To S
			N/A	X Walk 1 Width (in)	N/A
				X Walk 1 Slope (%)	2.1
				X Walk 1 X Slope (%)	0.2
<p>Surveyor Notes:</p> <p>N/A</p> <p>PROW/ADA:</p> <p>Not Found, R304.2.2, R304.5.3</p>			N/A	Flare Type RT	N/A
			N/A	Flare Slope RT (%)	N/A
			N/A	Flare Traversable RT?	N/A

N/A	DWS Provided?	N/A
			N/A	DWS Contrast?	N/A
			N/A	DWS Length (in)	N/A
			N/A	DWS Full Width?	N/A
			N/A	DWS Offset (in)	N/A
			N/A	Gutter Slope (%)	N/A
			N/A	Gutter X Slope (%)	N/A
			N/A	Painted X Walk2?	No
				X Walk 2 Direction	To E
			N/A	X Walk 2 Width (in)	N/A
				X Walk 2 Slope (%)	2.2
				X Walk 2 X Slope (%)	3.9
			N/A	Ramp inside XWalk2?	N/A
			N/A	Clear Space?	N/A
			N/A	Clear Space to XWalk (in)	N/A
			N/A	Storm Grate/Utility Hazard?	N/A
				Storm Grate/Utility Type	
<p>Total Cost:</p> <p>\$ 3200.00</p>			N/A		N/A
			Yes	Surface Condition? (G/P)	Good
