Access Compliance Report

Public Rights-of-Way

(Island Curb Cuts)

Intersection ID: 12267	Main Street: CENTRAL_AV	Cross Street: LOUISE_AV	Location: E
ADA ID: 00C8A36ED827	Curb Cut Type: MedianRefuge2	Initial Pass/Fail: Fail	Overall Compliance: No
Severity Score: 1.25			
Codes/Mitigation Info/Possible Solution		Field Measurements/Component Compliance

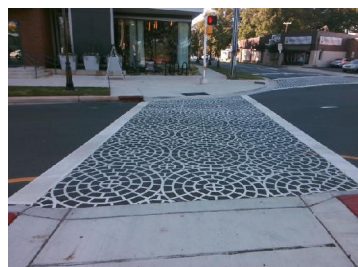
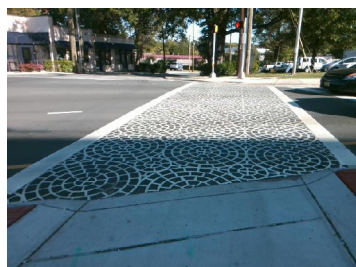
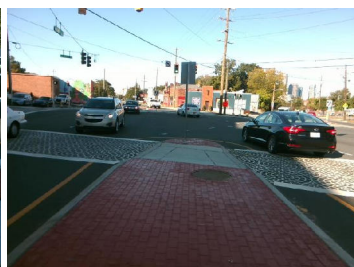
Compliance	Description	Data	Compliance	Description	Data
Yes	Refuge 1 Length (In)	45.0	N/A	Gutter 1 Ponding?	N/A
Yes	Refuge 1 Width (In)	91.0	N/A	Gutter 1 Lip Ht (In)	N/A
Yes	Refuge 1 Slope (%)	1.9	N/A	Gutter 1 Slope (%)	N/A
Yes	Refuge 1 X Slope (%)	2.9	N/A	Gutter 1 X Slope (%)	N/A
N/A	Painted X Walk1?	Yes	N/A	DWS 1 Provided?	N/A
N/A	X Walk 1 Direction	To NE	N/A	DWS 1 Contrast?	N/A
N/A	X Walk 1 Width (In)	144.0	N/A	DWS 1 Length (In)	N/A
N/A	Road 1 Slope (%)	0.1	N/A	DWS 1 Full Width?	N/A
N/A	Road 1 X Slope (%)	0.2	N/A	DWS 1 Offset (In)	N/A
Yes	Refuge 2 Length (In)	45.0	N/A	Gutter 2 Ponding?	N/A
Yes	Refuge 2 Width (In)	91.0	N/A	Gutter 2 Lip Ht (In)	N/A
Yes	Refuge 2 Slope (%)	2.2	N/A	Gutter 2 Slope (%)	N/A
Yes	Refuge 2 X Slope (%)	0.3	N/A	Gutter 2 X Slope (%)	N/A
N/A	Painted X Walk2?	Yes	N/A	DWS 2 Provided?	N/A
N/A	X Walk 2 Direction	To SW	N/A	DWS 2 Contrast?	N/A
N/A	X Walk 2 Width (In)	144.0	N/A	DWS 2 Length (In)	N/A

N/A	Road 2 Slope (%)	0.4	N/A	DWS 2 Full Width?	N/A
N/A	Road 2 X Slope (%)	2.7	N/A	DWS 2 Offset (In)	N/A
N/A	Refuge 3 Length (in)	N/A	N/A	Gutter 3 Ponding?	N/A
N/A	Refuge 3 Width (in)	N/A	N/A	Gutter 3 Lip Ht (in)	N/A
N/A	Refuge 3 Slope (%)	N/A	N/A	Gutter 3 Slope (%)	N/A
N/A	Refuge 3 XSlope (%)	N/A	N/A	Gutter 3 XSlope (%)	N/A
N/A	Painted X Walk3?	N/A	N/A	DWS 3 Provided?	N/A
N/A	X Walk 3 Direction	N/A	N/A	DWS 3 Contrast?	N/A
N/A	X Walk 3 Width (in)	N/A	N/A	DWS 3 Length (in)	N/A
N/A	Road 3 Slope (%)	N/A	N/A	DWS 3 Full Width?	N/A
N/A	Road 3 XSlope (%)	N/A	N/A	DWS 3 Offset (in)	N/A
Yes	Any Obstructions?	N/A	N/A	Storm Grate/Utility Hazard?	N/A
N/A	Obstruction Type		N/A	Storm Grate/Utility Type	
		N/A			N/A
N/A	Surface Condition	Good

Remove & Replace Entire Refuge.
