Access Compliance Report

Public Rights-of-Way

(Island Curb Cuts)

Intersection ID: 10003849	Main Street: DIXIE_RIVER_RD	Cross Street: NEW_FASHION_WY	Location: N
ADA ID: 025E34CD6DD5	Curb Cut Type: MedianRefuge2	Initial Pass/Fail: Fail	Overall Compliance: No
Severity Score: 1.25			
Codes/Mitigation Info/Possible Solution		Field Measurements/Component Compliance

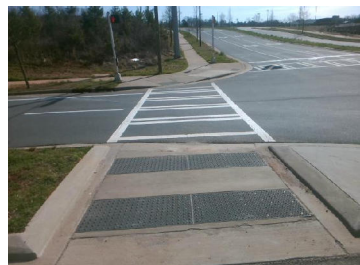
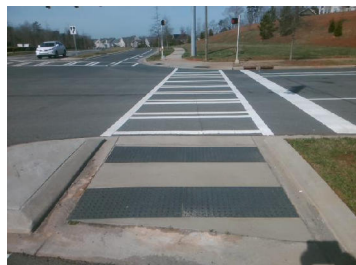
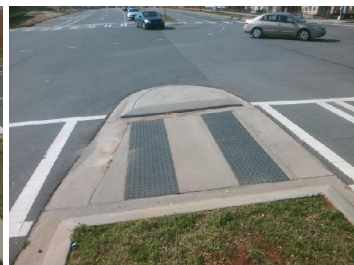
Compliance	Description	Data	Compliance	Description	Data
Yes	Refuge 1 Length (In)	40.0	N/A	Gutter 1 Ponding?	N/A
Yes	Refuge 1 Width (In)	114.0	N/A	Gutter 1 Lip Ht (In)	N/A
Yes	Refuge 1 Slope (%)	2.2	N/A	Gutter 1 Slope (%)	N/A
Yes	Refuge 1 X Slope (%)	2.2	N/A	Gutter 1 X Slope (%)	N/A
N/A	Painted X Walk1?	Yes	N/A	DWS 1 Provided?	N/A
N/A	X Walk 1 Direction	To E	N/A	DWS 1 Contrast?	N/A
N/A	X Walk 1 Width (In)	113.0	N/A	DWS 1 Length (In)	N/A
N/A	Road 1 Slope (%)	1.3	N/A	DWS 1 Full Width?	N/A
N/A	Road 1 X Slope (%)	2.1	N/A	DWS 1 Offset (In)	N/A
Yes	Refuge 2 Length (In)	40.0	N/A	Gutter 2 Ponding?	N/A
Yes	Refuge 2 Width (In)	114.0	N/A	Gutter 2 Lip Ht (In)	N/A
Yes	Refuge 2 Slope (%)	1.5	N/A	Gutter 2 Slope (%)	N/A
Yes	Refuge 2 X Slope (%)	1.9	N/A	Gutter 2 X Slope (%)	N/A
N/A	Painted X Walk2?	Yes	N/A	DWS 2 Provided?	N/A
N/A	X Walk 2 Direction	To W	N/A	DWS 2 Contrast?	N/A
N/A	X Walk 2 Width (In)	114.0	N/A	DWS 2 Length (In)	N/A

N/A	Road 2 Slope (%)	0.6	N/A	DWS 2 Full Width?	N/A
N/A	Road 2 X Slope (%)	1.7	N/A	DWS 2 Offset (In)	N/A
N/A	Refuge 3 Length (in)	N/A	N/A	Gutter 3 Ponding?	N/A
N/A	Refuge 3 Width (in)	N/A	N/A	Gutter 3 Lip Ht (in)	N/A
N/A	Refuge 3 Slope (%)	N/A	N/A	Gutter 3 Slope (%)	N/A
N/A	Refuge 3 XSlope (%)	N/A	N/A	Gutter 3 XSlope (%)	N/A
N/A	Painted X Walk3?	N/A	N/A	DWS 3 Provided?	N/A
N/A	X Walk 3 Direction	N/A	N/A	DWS 3 Contrast?	N/A
N/A	X Walk 3 Width (in)	N/A	N/A	DWS 3 Length (in)	N/A
N/A	Road 3 Slope (%)	N/A	N/A	DWS 3 Full Width?	N/A
N/A	Road 3 XSlope (%)	N/A	N/A	DWS 3 Offset (in)	N/A
Yes	Any Obstructions?	N/A	N/A	Storm Grate/Utility Hazard?	N/A
N/A	Obstruction Type		N/A	Storm Grate/Utility Type	
		N/A			N/A
N/A	Surface Condition	Good

Remove & Replace Entire Refuge.
