Access Compliance Report

Public Rights-of-Way

(Island Curb Cuts)

Intersection ID: 10031974	Main Street: MONROE_RD	Cross Street: N/A	Location: N
ADA ID: 02B49A15AE16	Curb Cut Type: MedianRefuge2	Initial Pass/Fail: Fail	Overall Compliance: No
		Severity Score: 0

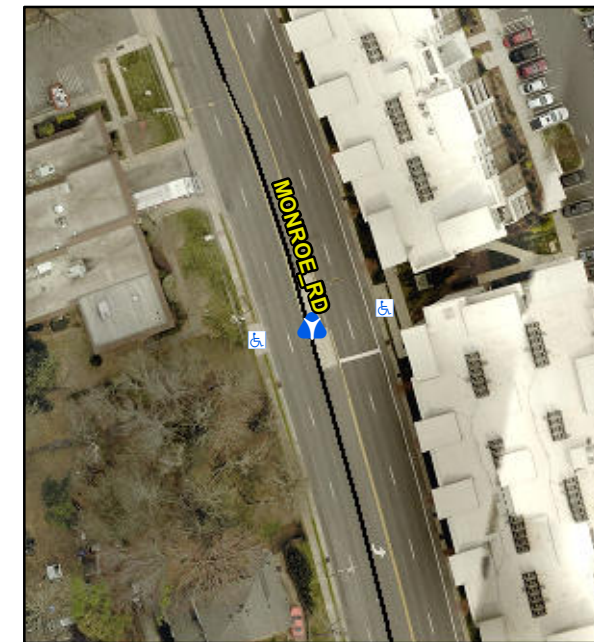
Compliance	Description	Data	Compliance	Description	Data
Yes	Refuge 1 Length (In)	54.0	N/A	Gutter 1 Ponding?	N/A
Yes	Refuge 1 Width (In)	120.0	N/A	Gutter 1 Lip Ht (In)	N/A
Yes	Refuge 1 Slope (%)	1.7	N/A	Gutter 1 Slope (%)	N/A
Yes	Refuge 1 X Slope (%)	3.0	N/A	Gutter 1 X Slope (%)	N/A
N/A	Painted X Walk1?	No	N/A	DWS 1 Provided?	N/A
N/A	X Walk 1 Direction	To NE	N/A	DWS 1 Contrast?	N/A
N/A	X Walk 1 Width (In)	N/A	N/A	DWS 1 Length (In)	N/A
N/A	Road 1 Slope (%)	0.5	N/A	DWS 1 Full Width?	N/A
N/A	Road 1 X Slope (%)	3.5	N/A	DWS 1 Offset (In)	N/A
Yes	Refuge 2 Length (In)	54.0	N/A	Gutter 2 Ponding?	N/A
Yes	Refuge 2 Width (In)	120.0	N/A	Gutter 2 Lip Ht (In)	N/A
Yes	Refuge 2 Slope (%)	0.9	N/A	Gutter 2 Slope (%)	N/A
Yes	Refuge 2 X Slope (%)	0.9	N/A	Gutter 2 X Slope (%)	N/A
N/A	Painted X Walk2?	No	N/A	DWS 2 Provided?	N/A
N/A	X Walk 2 Direction	To SW	N/A	DWS 2 Contrast?	N/A
N/A	X Walk 2 Width (In)	N/A	N/A	DWS 2 Length (In)	N/A

N/A	Road 2 Slope (%)	0.7	N/A	DWS 2 Full Width?	N/A
N/A	Road 2 X Slope (%)	5.0	N/A	DWS 2 Offset (In)	N/A
N/A	Refuge 3 Length (in)	N/A	N/A	Gutter 3 Ponding?	N/A
N/A	Refuge 3 Width (in)	N/A	N/A	Gutter 3 Lip Ht (in)	N/A
N/A	Refuge 3 Slope (%)	N/A	N/A	Gutter 3 Slope (%)	N/A
N/A	Refuge 3 XSlope (%)	N/A	N/A	Gutter 3 XSlope (%)	N/A
N/A	Painted X Walk3?	N/A	N/A	DWS 3 Provided?	N/A
N/A	X Walk 3 Direction	N/A	N/A	DWS 3 Contrast?	N/A
N/A	X Walk 3 Width (in)	N/A	N/A	DWS 3 Length (in)	N/A
N/A	Road 3 Slope (%)	N/A	N/A	DWS 3 Full Width?	N/A
N/A	Road 3 XSlope (%)	N/A	N/A	DWS 3 Offset (in)	N/A
Yes	Any Obstructions?	N/A	N/A	Storm Grate/Utility Hazard?	N/A
N/A	Obstruction Type		N/A	Storm Grate/Utility Type	
		N/A			N/A
N/A	Surface Condition	Good

Remove & Replace Entire Refuge.
