Access Compliance Report

Public Rights-of-Way

(Island Curb Cuts)

Intersection ID: 10025609	Main Street: E_WOODLAWN_RD	Cross Street: N/A	Location: S
ADA ID: 03573A8093F8	Curb Cut Type: MedianRefuge2	Initial Pass/Fail: Fail	Overall Compliance: No
Codes/Mitigation Info/Possible Solution		Field Measurements/Component Compliance

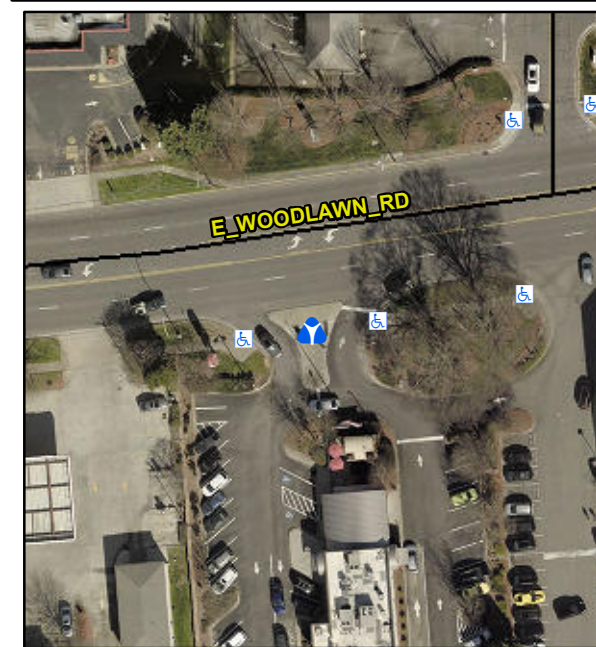
Compliance	Description	Data	Compliance	Description	Data
Yes	Refuge 1 Length (In)	101.0	N/A	Gutter 1 Ponding?	N/A
Yes	Refuge 1 Width (In)	98.0	N/A	Gutter 1 Lip Ht (In)	N/A
Yes	Refuge 1 Slope (%)	4.7	N/A	Gutter 1 Slope (%)	N/A
Yes	Refuge 1 X Slope (%)	3.8	N/A	Gutter 1 X Slope (%)	N/A
N/A	Painted X Walk1?	No	N/A	DWS 1 Provided?	N/A
N/A	X Walk 1 Direction	To E	N/A	DWS 1 Contrast?	N/A
N/A	X Walk 1 Width (In)	N/A	N/A	DWS 1 Length (In)	N/A
N/A	Road 1 Slope (%)	4.4	N/A	DWS 1 Full Width?	N/A
N/A	Road 1 X Slope (%)	4.7	N/A	DWS 1 Offset (In)	N/A
Yes	Refuge 2 Length (In)	101.0	N/A	Gutter 2 Ponding?	N/A
Yes	Refuge 2 Width (In)	98.0	N/A	Gutter 2 Lip Ht (In)	N/A
No	Refuge 2 Slope (%)	5.1	N/A	Gutter 2 Slope (%)	N/A
Yes	Refuge 2 X Slope (%)	1.8	N/A	Gutter 2 X Slope (%)	N/A
N/A	Painted X Walk2?	No	N/A	DWS 2 Provided?	N/A
N/A	X Walk 2 Direction	To W	N/A	DWS 2 Contrast?	N/A
N/A	X Walk 2 Width (In)	N/A	N/A	DWS 2 Length (In)	N/A

N/A	Road 2 Slope (%)	0.4	N/A	DWS 2 Full Width?	N/A
N/A	Road 2 X Slope (%)	4.6	N/A	DWS 2 Offset (In)	N/A
N/A	Refuge 3 Length (in)	N/A	N/A	Gutter 3 Ponding?	N/A
N/A	Refuge 3 Width (in)	N/A	N/A	Gutter 3 Lip Ht (in)	N/A
N/A	Refuge 3 Slope (%)	N/A	N/A	Gutter 3 Slope (%)	N/A
N/A	Refuge 3 XSlope (%)	N/A	N/A	Gutter 3 XSlope (%)	N/A
N/A	Painted X Walk3?	N/A	N/A	DWS 3 Provided?	N/A
N/A	X Walk 3 Direction	N/A	N/A	DWS 3 Contrast?	N/A
N/A	X Walk 3 Width (in)	N/A	N/A	DWS 3 Length (in)	N/A
N/A	Road 3 Slope (%)	N/A	N/A	DWS 3 Full Width?	N/A
N/A	Road 3 XSlope (%)	N/A	N/A	DWS 3 Offset (in)	N/A
Yes	Any Obstructions?	N/A	N/A	Storm Grate/Utility Hazard?	N/A
N/A	Obstruction Type		N/A	Storm Grate/Utility Type	
		N/A			N/A
N/A	Surface Condition	Good

Possible Solutions:

Remove & Replace Entire Refuge.
