Access Compliance Report

Public Rights-of-Way

(Island Curb Cuts)

Intersection ID: 7375	Main Street: N_TRYON_ST	Cross Street: TOM_HUNTER_RD	Location: E
ADA ID: 03A2601F0A64	Curb Cut Type: MedianRefuge2	Initial Pass/Fail: Fail	Overall Compliance: No
Codes/Mitigation Info/Possible Solution		Field Measurements/Component Compliance	
Severity Score: 0

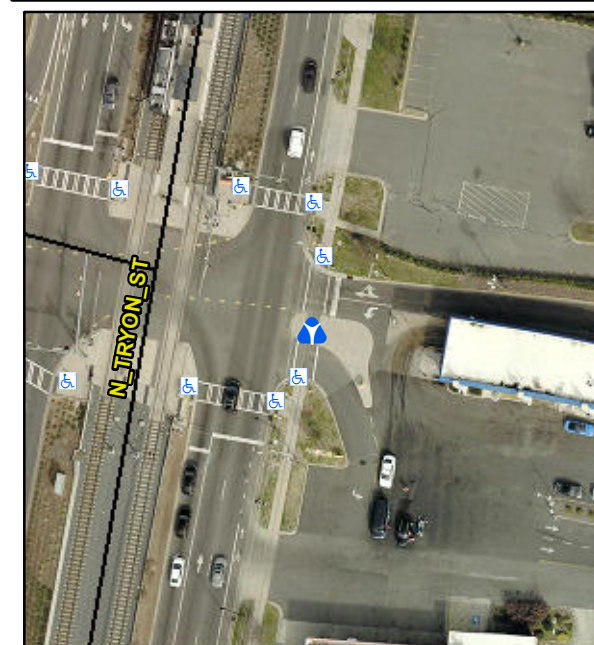
Compliance	Description	Data	Compliance	Description	Data
Yes	Refuge 1 Length (In)	90.0	N/A	Gutter 1 Ponding?	N/A
Yes	Refuge 1 Width (In)	85.0	N/A	Gutter 1 Lip Ht (In)	N/A
Yes	Refuge 1 Slope (%)	0.7	N/A	Gutter 1 Slope (%)	N/A
Yes	Refuge 1 X Slope (%)	4.4	N/A	Gutter 1 X Slope (%)	N/A
N/A	Painted X Walk1?	Yes	N/A	DWS 1 Provided?	N/A
N/A	X Walk 1 Direction	To N	N/A	DWS 1 Contrast?	N/A
N/A	X Walk 1 Width (In)	119.0	N/A	DWS 1 Length (In)	N/A
N/A	Road 1 Slope (%)	4.3	N/A	DWS 1 Full Width?	N/A
N/A	Road 1 X Slope (%)	1.3	N/A	DWS 1 Offset (In)	N/A
Yes	Refuge 2 Length (In)	90.0	N/A	Gutter 2 Ponding?	N/A
Yes	Refuge 2 Width (In)	85.0	N/A	Gutter 2 Lip Ht (In)	N/A
Yes	Refuge 2 Slope (%)	0.9	N/A	Gutter 2 Slope (%)	N/A
Yes	Refuge 2 X Slope (%)	4.0	N/A	Gutter 2 X Slope (%)	N/A
N/A	Painted X Walk2?	Yes	N/A	DWS 2 Provided?	N/A
N/A	X Walk 2 Direction	To S	N/A	DWS 2 Contrast?	N/A
N/A	X Walk 2 Width (In)	119.0	N/A	DWS 2 Length (In)	N/A

N/A	Road 2 Slope (%)	2.6	N/A	DWS 2 Full Width?	N/A
N/A	Road 2 X Slope (%)	2.5	N/A	DWS 2 Offset (In)	N/A
N/A	Refuge 3 Length (in)	N/A	N/A	Gutter 3 Ponding?	N/A
N/A	Refuge 3 Width (in)	N/A	N/A	Gutter 3 Lip Ht (in)	N/A
N/A	Refuge 3 Slope (%)	N/A	N/A	Gutter 3 Slope (%)	N/A
N/A	Refuge 3 XSlope (%)	N/A	N/A	Gutter 3 XSlope (%)	N/A
N/A	Painted X Walk3?	N/A	N/A	DWS 3 Provided?	N/A
N/A	X Walk 3 Direction	N/A	N/A	DWS 3 Contrast?	N/A
N/A	X Walk 3 Width (in)	N/A	N/A	DWS 3 Length (in)	N/A
N/A	Road 3 Slope (%)	N/A	N/A	DWS 3 Full Width?	N/A
N/A	Road 3 XSlope (%)	N/A	N/A	DWS 3 Offset (in)	N/A
Yes	Any Obstructions?	N/A	N/A	Storm Grate/Utility Hazard?	N/A
N/A	Obstruction Type		N/A	Storm Grate/Utility Type	
		N/A			N/A
N/A	Surface Condition	Good

Possible Solutions:

Remove & Replace Entire Refuge.

Total Cost: \$ 3000.00
