Access Compliance Report

Public Rights-of-Way

(Island Curb Cuts)

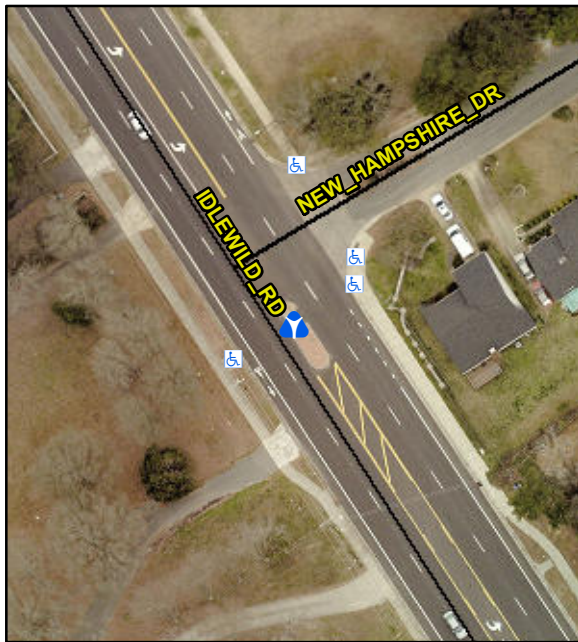
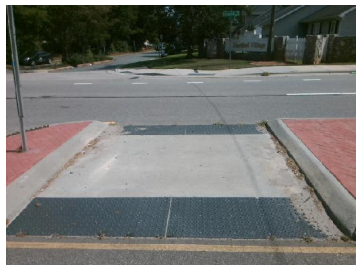
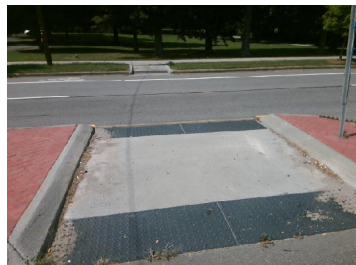
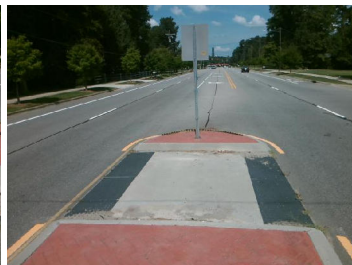
Intersection ID: 17298	Main Street: IDLEWILD_RD	Cross Street: NEW_HAMPSHIRE_DR	Location: SE
ADA ID: 0480B5E4B8AC	Curb Cut Type: MedianRefuge2	Initial Pass/Fail: Fail	Overall Compliance: No
Codes/Mitigation Info/Possible Solution		Field Measurements/Component Compliance	
Severity Score: 1.25

Compliance	Description	Data	Compliance	Description	Data
Yes	Refuge 1 Length (In)	65.0	N/A	Gutter 1 Ponding?	N/A
Yes	Refuge 1 Width (In)	121.0	N/A	Gutter 1 Lip Ht (In)	N/A
Yes	Refuge 1 Slope (%)	1.7	N/A	Gutter 1 Slope (%)	N/A
Yes	Refuge 1 X Slope (%)	0.4	N/A	Gutter 1 X Slope (%)	N/A
N/A	Painted X Walk1?	No	N/A	DWS 1 Provided?	N/A
N/A	X Walk 1 Direction	To NE	N/A	DWS 1 Contrast?	N/A
N/A	X Walk 1 Width (In)	N/A	N/A	DWS 1 Length (In)	N/A
N/A	Road 1 Slope (%)	1.9	N/A	DWS 1 Full Width?	N/A
N/A	Road 1 X Slope (%)	2.8	N/A	DWS 1 Offset (In)	N/A
Yes	Refuge 2 Length (In)	65.0	N/A	Gutter 2 Ponding?	N/A
Yes	Refuge 2 Width (In)	121.0	N/A	Gutter 2 Lip Ht (In)	N/A
Yes	Refuge 2 Slope (%)	2.2	N/A	Gutter 2 Slope (%)	N/A
Yes	Refuge 2 X Slope (%)	3.2	N/A	Gutter 2 X Slope (%)	N/A
N/A	Painted X Walk2?	No	N/A	DWS 2 Provided?	N/A
N/A	X Walk 2 Direction	To SW	N/A	DWS 2 Contrast?	N/A
N/A	X Walk 2 Width (In)	N/A	N/A	DWS 2 Length (In)	N/A

N/A	Road 2 Slope (%)	1.8	N/A	DWS 2 Full Width?	N/A
N/A	Road 2 X Slope (%)	3.7	N/A	DWS 2 Offset (In)	N/A
N/A	Refuge 3 Length (in)	N/A	N/A	Gutter 3 Ponding?	N/A
N/A	Refuge 3 Width (in)	N/A	N/A	Gutter 3 Lip Ht (in)	N/A
N/A	Refuge 3 Slope (%)	N/A	N/A	Gutter 3 Slope (%)	N/A
N/A	Refuge 3 XSlope (%)	N/A	N/A	Gutter 3 XSlope (%)	N/A
N/A	Painted X Walk3?	N/A	N/A	DWS 3 Provided?	N/A
N/A	X Walk 3 Direction	N/A	N/A	DWS 3 Contrast?	N/A
N/A	X Walk 3 Width (in)	N/A	N/A	DWS 3 Length (in)	N/A
N/A	Road 3 Slope (%)	N/A	N/A	DWS 3 Full Width?	N/A
N/A	Road 3 XSlope (%)	N/A	N/A	DWS 3 Offset (in)	N/A
Yes	Any Obstructions?	N/A	N/A	Storm Grate/Utility Hazard?	N/A
N/A	Obstruction Type		N/A	Storm Grate/Utility Type	
		N/A			N/A
N/A	Surface Condition	Good

Remove & Replace Entire Refuge.
