Access Compliance Report

Public Rights-of-Way

(Island Curb Cuts)

Intersection ID: 28304	Main Street: LANCASTER_HY	Cross Street: JOHNSTON_RD	Location: SE
ADA ID: 05B268E377AE	Curb Cut Type: MedianRefuge2	Initial Pass/Fail: Fail	Overall Compliance: No
Severity Score: 25			
Codes/Mitigation Info/Possible Solution		Field Measurements/Component Compliance

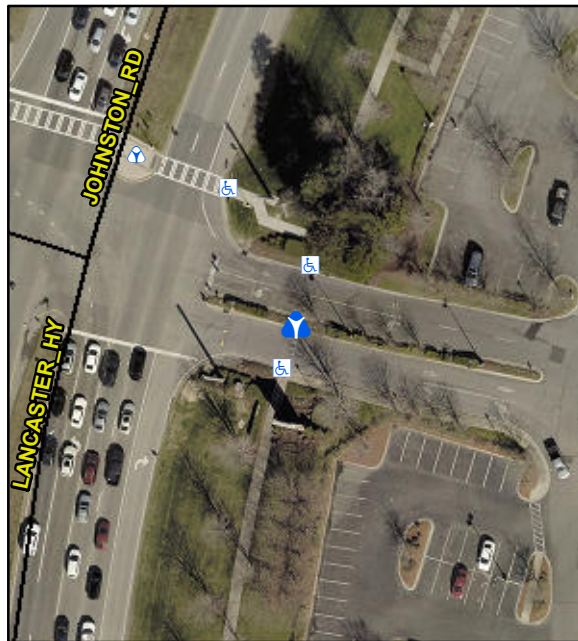
Compliance	Description	Data	Compliance	Description	Data
No	Refuge 1 Length (In)	30.0	N/A	Gutter 1 Ponding?	N/A
Yes	Refuge 1 Width (In)	71.0	N/A	Gutter 1 Lip Ht (In)	N/A
No	Refuge 1 Slope (%)	8.4	N/A	Gutter 1 Slope (%)	N/A
Yes	Refuge 1 X Slope (%)	2.7	N/A	Gutter 1 X Slope (%)	N/A
N/A	Painted X Walk1?	Yes	N/A	DWS 1 Provided?	N/A
N/A	X Walk 1 Direction	To SW	N/A	DWS 1 Contrast?	N/A
N/A	X Walk 1 Width (In)	60.0	N/A	DWS 1 Length (In)	N/A
N/A	Road 1 Slope (%)	2.4	N/A	DWS 1 Full Width?	N/A
N/A	Road 1 X Slope (%)	2.5	N/A	DWS 1 Offset (In)	N/A
No	Refuge 2 Length (In)	30.0	N/A	Gutter 2 Ponding?	N/A
Yes	Refuge 2 Width (In)	71.0	N/A	Gutter 2 Lip Ht (In)	N/A
No	Refuge 2 Slope (%)	5.1	N/A	Gutter 2 Slope (%)	N/A
Yes	Refuge 2 X Slope (%)	2.6	N/A	Gutter 2 X Slope (%)	N/A
N/A	Painted X Walk2?	Yes	N/A	DWS 2 Provided?	N/A
N/A	X Walk 2 Direction	To NE	N/A	DWS 2 Contrast?	N/A
N/A	X Walk 2 Width (In)	62.0	N/A	DWS 2 Length (In)	N/A

Remove & Replace Entire Refuge.

Total Cost: \$ 3000.00

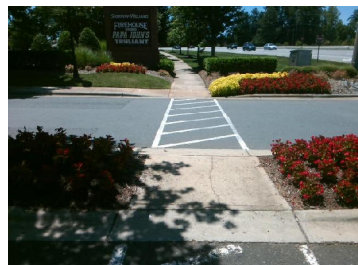
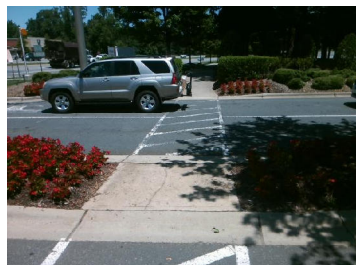
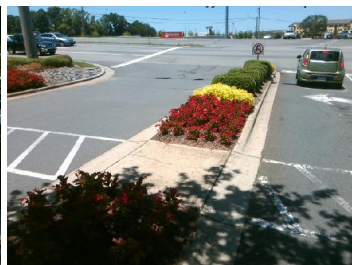
N/A	Road 2 Slope (%)	2.0	N/A	DWS 2 Full Width?	N/A
N/A	Road 2 X Slope (%)	2.7	N/A	DWS 2 Offset (In)	N/A
N/A	Refuge 3 Length (in)	N/A	N/A	Gutter 3 Ponding?	N/A
N/A	Refuge 3 Width (in)	N/A	N/A	Gutter 3 Lip Ht (in)	N/A
N/A	Refuge 3 Slope (%)	N/A	N/A	Gutter 3 Slope (%)	N/A
N/A	Refuge 3 XSlope (%)	N/A	N/A	Gutter 3 XSlope (%)	N/A
N/A	Painted X Walk3?	N/A	N/A	DWS 3 Provided?	N/A
N/A	X Walk 3 Direction	N/A	N/A	DWS 3 Contrast?	N/A
N/A	X Walk 3 Width (in)	N/A	N/A	DWS 3 Length (in)	N/A
N/A	Road 3 Slope (%)	N/A	N/A	DWS 3 Full Width?	N/A
N/A	Road 3 XSlope (%)	N/A	N/A	DWS 3 Offset (in)	N/A
Yes	Any Obstructions?	N/A	N/A	Storm Grate/Utility Hazard?	N/A
N/A	Obstruction Type		N/A	Storm Grate/Utility Type	
		N/A			N/A
N/A	Surface Condition	Good
