# Access Compliance Report

## Public Rights-of-Way

### (Island Curb Cuts)

Intersection ID: 6640	Main Street: ARVIN_DR	Cross Street: COCHRANE_DR	Location:	N
ADA ID: 0739B0B4FA27	Curb Cut Type: MedianRefuge2	Initial Pass/Fail: Pass	Overall Compliance: No	Severity Score: 25.25
Codes/Mitigation Info/Possible Solution		Field Measurements/Component Compliance

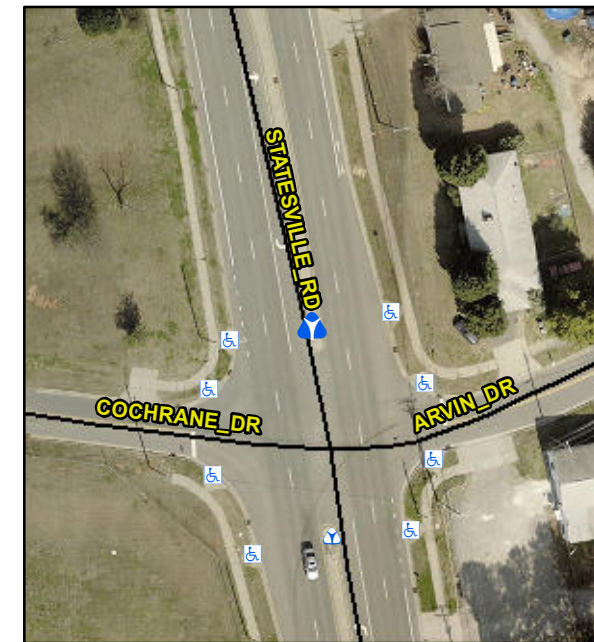
Compliance	Description	Data	Compliance	Description	Data
Yes	Refuge 1 Length (In)	36.5	No	Gutter 1 Ponding?	Yes
Yes	Refuge 1 Width (In)	95.0	No	Gutter 1 Lip Ht (In)	1.0
Yes	Refuge 1 Slope (%)	0.7	Yes	Gutter 1 Slope (%)	0.6
Yes	Refuge 1 X Slope (%)	0.3	Yes	Gutter 1 X Slope (%)	1.4
N/A	Painted X Walk1?	No	Yes	DWS 1 Provided?	Yes
N/A	X Walk 1 Direction	To E	Yes	DWS 1 Contrast?	Yes
N/A	X Walk 1 Width (In)	N/A	Yes	DWS 1 Length (In)	24.0
N/A	Road 1 Slope (%)	1.3	Yes	DWS 1 Full Width?	Yes
N/A	Road 1 X Slope (%)	0.1	Yes	DWS 1 Offset (In)	0.0
Yes	Refuge 2 Length (In)	36.5	No	Gutter 2 Ponding?	Yes
Yes	Refuge 2 Width (In)	95.0	No	Gutter 2 Lip Ht (In)	0.25
Yes	Refuge 2 Slope (%)	4.0	No	Gutter 2 Slope (%)	8.2
Yes	Refuge 2 X Slope (%)	0.8	Yes	Gutter 2 X Slope (%)	0.8
N/A	Painted X Walk2?	No	Yes	DWS 2 Provided?	Yes
N/A	X Walk 2 Direction	To W	Yes	DWS 2 Contrast?	Yes
N/A	X Walk 2 Width (In)	N/A	Yes	DWS 2 Length (In)	24.0

N/A	Road 2 Slope (%)	0.7	Yes	DWS 2 Full Width?	Yes
N/A	Road 2 X Slope (%)	2.3	Yes	DWS 2 Offset (In)	0.0
N/A	Refuge 3 Length (in)	N/A	N/A	Gutter 3 Ponding?	No
N/A	Refuge 3 Width (in)	N/A	N/A	Gutter 3 Lip Ht (in)	N/A
N/A	Refuge 3 Slope (%)	N/A	N/A	Gutter 3 Slope (%)	N/A
N/A	Refuge 3 XSlope (%)	N/A	N/A	Gutter 3 XSlope (%)	N/A
N/A	Painted X Walk3?	No	N/A	DWS 3 Provided?	N/A
N/A	X Walk 3 Direction	N/A	N/A	DWS 3 Contrast?	N/A
N/A	X Walk 3 Width (in)	N/A	N/A	DWS 3 Length (in)	N/A
N/A	Road 3 Slope (%)	N/A	N/A	DWS 3 Full Width?	N/A
N/A	Road 3 XSlope (%)	N/A	N/A	DWS 3 Offset (in)	N/A
Yes	Any Obstructions?	No	N/A	Storm Grate/Utility Hazard?	No
N/A	Obstruction Type		N/A	Storm Grate/Utility Type	
		N/A			N/A
N/A	Surface Condition	Good

Possible Solutions:

**Grind Gutter Lip. Remove & Replace Gutter.**
