Access Compliance Report

Public Rights-of-Way

(Island Curb Cuts)

Intersection ID: 10868	Main Street: N_TRYON_ST	Cross Street: DALTON_AV	Location: SW
ADA ID: 0773AAA0C2C1	Curb Cut Type: IslandRefuge3	Initial Pass/Fail: Pass	Overall Compliance: No
Severity Score: 17.5			
Codes/Mitigation Info/Possible Solution		Field Measurements/Component Compliance

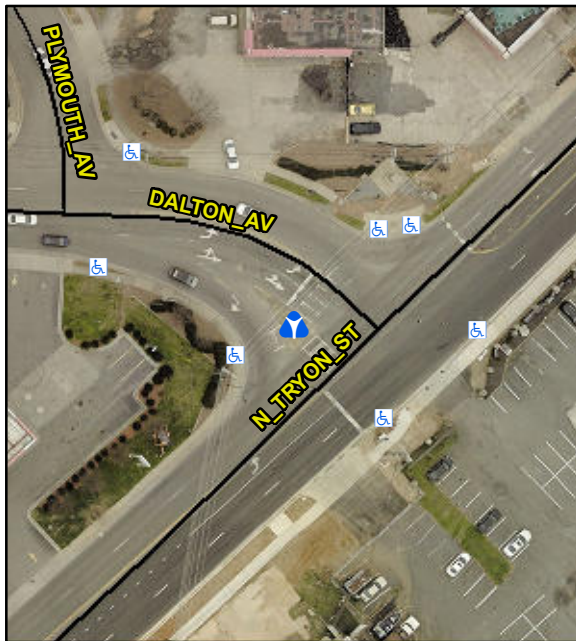
Compliance	Description	Data	Compliance	Description	Data
No	Refuge 1 Length (In)	34.5	Yes	Gutter 1 Ponding?	No
Yes	Refuge 1 Width (In)	85.0	No	Gutter 1 Lip Ht (In)	0.5
Yes	Refuge 1 Slope (%)	0.2	Yes	Gutter 1 Slope (%)	0.6
Yes	Refuge 1 X Slope (%)	0.3	Yes	Gutter 1 X Slope (%)	0.0
N/A	Painted X Walk1?	Yes	No	DWS 1 Provided?	Yes
N/A	X Walk 1 Direction	To SW	N/A	DWS 1 Contrast?	Yes
N/A	X Walk 1 Width (In)	113.5	N/A	DWS 1 Length (In)	24.0
N/A	Road 1 Slope (%)	0.8	N/A	DWS 1 Full Width?	No
N/A	Road 1 X Slope (%)	0.3	N/A	DWS 1 Offset (In)	20.5
No	Refuge 2 Length (In)	30.0	Yes	Gutter 2 Ponding?	No
Yes	Refuge 2 Width (In)	85.0	No	Gutter 2 Lip Ht (In)	0.5
Yes	Refuge 2 Slope (%)	0.8	Yes	Gutter 2 Slope (%)	1.3
Yes	Refuge 2 X Slope (%)	1.8	Yes	Gutter 2 X Slope (%)	1.2
N/A	Painted X Walk2?	Yes	No	DWS 2 Provided?	Yes
N/A	X Walk 2 Direction	To NE	N/A	DWS 2 Contrast?	Yes
N/A	X Walk 2 Width (In)	112.0	N/A	DWS 2 Length (In)	24.0

N/A	Road 2 Slope (%)	1.2	N/A	DWS 2 Full Width?	No
N/A	Road 2 X Slope (%)	0.5	N/A	DWS 2 Offset (In)	2.5
No	Refuge 3 Length (in)	73.0	Yes	Gutter 3 Ponding?	No
Yes	Refuge 3 Width (in)	73.5	Yes	Gutter 3 Lip Ht (in)	0.0
Yes	Refuge 3 Slope (%)	1.7	Yes	Gutter 3 Slope (%)	1.9
Yes	Refuge 3 XSlope (%)	0.3	Yes	Gutter 3 XSlope (%)	1.6
N/A	Painted X Walk3?	Yes	No	DWS 3 Provided?	Yes
N/A	X Walk 3 Direction	To SE	N/A	DWS 3 Contrast?	Yes
N/A	X Walk 3 Width (in)	107.0	N/A	DWS 3 Length (in)	24.0
N/A	Road 3 Slope (%)	1.1	N/A	DWS 3 Full Width?	No
N/A	Road 3 XSlope (%)	1.2	N/A	DWS 3 Offset (in)	2.5
Yes	Any Obstructions?	No	N/A	Storm Grate/Utility Hazard?	No
N/A	Obstruction Type	N/A	N/A	Storm Grate/Utility Type	N/A
N/A	Surface Condition	Good

Possible Solutions:

**Remove & Replace Entire Refuge.
Grind Gutter Lip.**

Total Cost: \$ 3400.00
