Access Compliance Report

Public Rights-of-Way

(Island Curb Cuts)

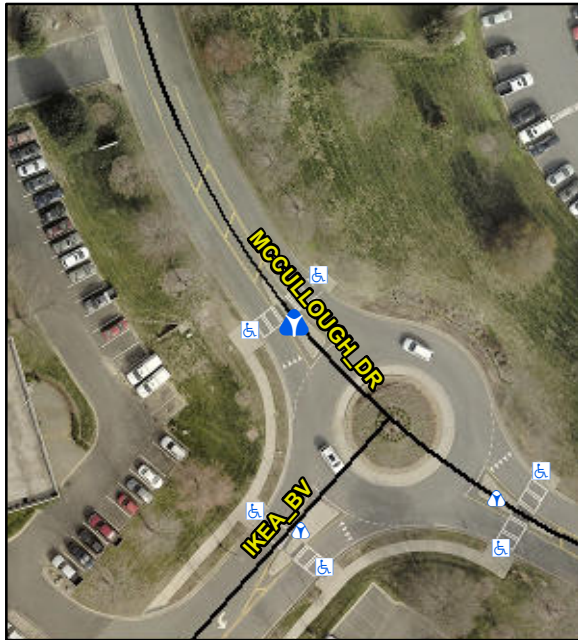
Intersection ID: 52600	Main Street: MCCULLOUGH_DR	Cross Street: IKEA_BV	Location: NW
ADA ID: 0798968FAB78	Curb Cut Type: MedianRefuge2	Initial Pass/Fail: Fail	Overall Compliance: No
Codes/Mitigation Info/Possible Solution		Field Measurements/Component Compliance	
Severity Score: 0

Possible Solutions:

Remove & Replace Entire Refuge.
