Access Compliance Report

Public Rights-of-Way

(Island Curb Cuts)

Intersection ID: 3034	Main Street: JUNE WILLIAM LN	Cross Street: JOHNSTON OEHLER RD	Location: SE
ADA ID: 0821DFD00DD2	Curb Cut Type: MedianRefuge2	Initial Pass/Fail: Pass	Overall Compliance: No
Codes/Mitigation Info/Possible Solution		Field Measurements/Component Compliance	
		Severity Score: 0

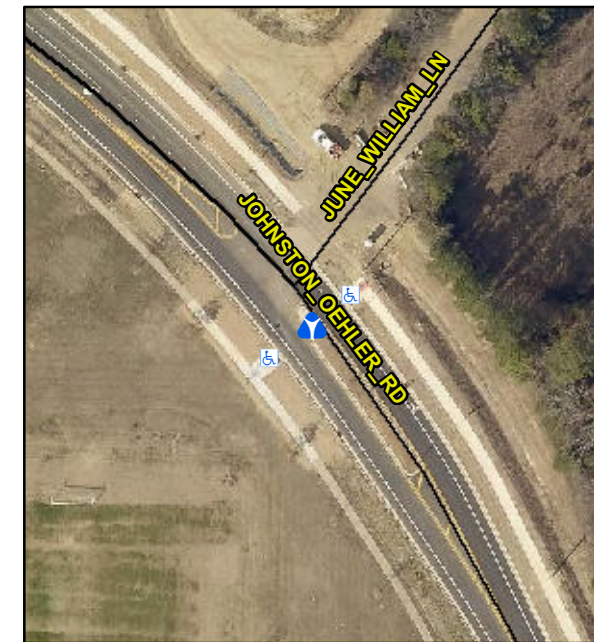
Compliance	Description	Data	Compliance	Description	Data
No	Refuge 1 Length (In)	28.0	No	Gutter 1 Ponding?	Yes
Yes	Refuge 1 Width (In)	96.0	Yes	Gutter 1 Lip Ht (In)	0.0
Yes	Refuge 1 Slope (%)	0.7	Yes	Gutter 1 Slope (%)	1.0
Yes	Refuge 1 X Slope (%)	1.4	Yes	Gutter 1 X Slope (%)	0.6
N/A	Painted X Walk1?	No	No	DWS 1 Provided?	Yes
N/A	X Walk 1 Direction	To SW	N/A	DWS 1 Contrast?	Yes
N/A	X Walk 1 Width (In)	N/A	N/A	DWS 1 Length (In)	24.0
N/A	Road 1 Slope (%)	1.7	N/A	DWS 1 Full Width?	Yes
N/A	Road 1 X Slope (%)	0.2	N/A	DWS 1 Offset (In)	23.0
No	Refuge 2 Length (In)	28.0	Yes	Gutter 2 Ponding?	No
Yes	Refuge 2 Width (In)	96.0	No	Gutter 2 Lip Ht (In)	N/A
Yes	Refuge 2 Slope (%)	1.4	Yes	Gutter 2 Slope (%)	0.3
Yes	Refuge 2 X Slope (%)	1.5	Yes	Gutter 2 X Slope (%)	1.3
N/A	Painted X Walk2?	No	No	DWS 2 Provided?	Yes
N/A	X Walk 2 Direction	To NE	N/A	DWS 2 Contrast?	Yes
N/A	X Walk 2 Width (In)	N/A	N/A	DWS 2 Length (In)	24.0

N/A	Road 2 Slope (%)	0.9	N/A	DWS 2 Full Width?	Yes
N/A	Road 2 X Slope (%)	3.1	N/A	DWS 2 Offset (In)	0.0
N/A	Refuge 3 Length (in)	N/A	N/A	Gutter 3 Ponding?	No
N/A	Refuge 3 Width (in)	N/A	N/A	Gutter 3 Lip Ht (in)	N/A
N/A	Refuge 3 Slope (%)	N/A	N/A	Gutter 3 Slope (%)	N/A
N/A	Refuge 3 XSlope (%)	N/A	N/A	Gutter 3 XSlope (%)	N/A
N/A	Painted X Walk3?	No	N/A	DWS 3 Provided?	N/A
N/A	X Walk 3 Direction	N/A	N/A	DWS 3 Contrast?	N/A
N/A	X Walk 3 Width (in)	N/A	N/A	DWS 3 Length (in)	N/A
N/A	Road 3 Slope (%)	N/A	N/A	DWS 3 Full Width?	N/A
N/A	Road 3 XSlope (%)	N/A	N/A	DWS 3 Offset (in)	N/A
Yes	Any Obstructions?	No	N/A	Storm Grate/Utility Hazard?	No
N/A	Obstruction Type		N/A	Storm Grate/Utility Type	
		N/A			N/A
N/A	Surface Condition	Good

**Remove & Replace Entire Refuge.
Fix Gutter Ponding. Grind Gutter
Lip.**
