# Access Compliance Report

## Public Rights-of-Way

### (Island Curb Cuts)

Intersection ID: 51491	Main Street: N_TRYON_ST	Cross Street: INSTITUTE_CR	Location: W
ADA ID: 0893EBFA2BD2	Curb Cut Type: MedianRefuge2	Initial Pass/Fail: Fail	Overall Compliance: No
Codes/Mitigation Info/Possible Solution		Field Measurements/Component Compliance	
Severity Score: 1.25

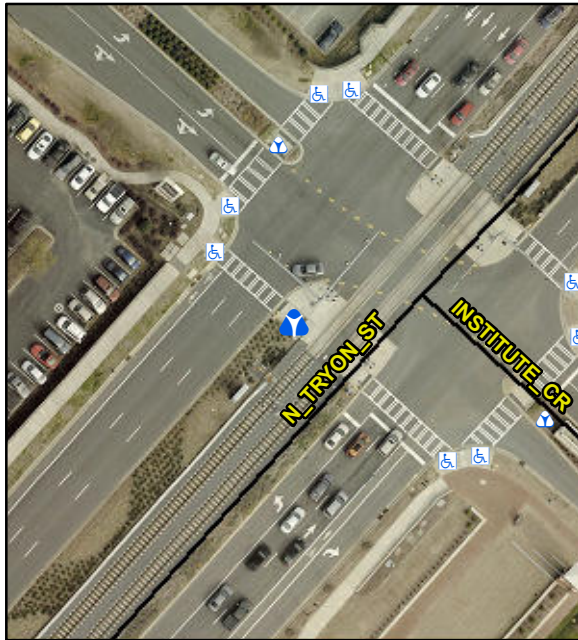
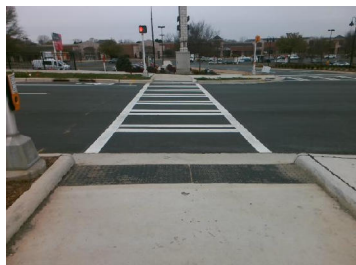
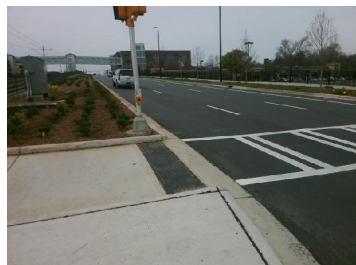
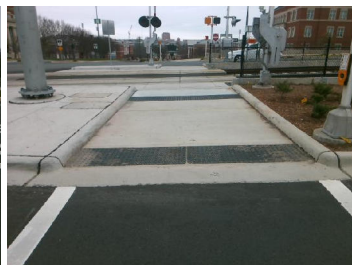
Compliance	Description	Data	Compliance	Description	Data
Yes	Refuge 1 Length (In)	132.5	N/A	Gutter 1 Ponding?	N/A
Yes	Refuge 1 Width (In)	120.0	N/A	Gutter 1 Lip Ht (In)	N/A
Yes	Refuge 1 Slope (%)	3.2	N/A	Gutter 1 Slope (%)	N/A
Yes	Refuge 1 X Slope (%)	3.3	N/A	Gutter 1 X Slope (%)	N/A
N/A	Painted X Walk1?	Yes	N/A	DWS 1 Provided?	N/A
N/A	X Walk 1 Direction	To W	N/A	DWS 1 Contrast?	N/A
N/A	X Walk 1 Width (In)	99.0	N/A	DWS 1 Length (In)	N/A
N/A	Road 1 Slope (%)	3.9	N/A	DWS 1 Full Width?	N/A
N/A	Road 1 X Slope (%)	3.9	N/A	DWS 1 Offset (In)	N/A
Yes	Refuge 2 Length (In)	132.5	N/A	Gutter 2 Ponding?	N/A
Yes	Refuge 2 Width (In)	120.0	N/A	Gutter 2 Lip Ht (In)	N/A
No	Refuge 2 Slope (%)	N/A	N/A	Gutter 2 Slope (%)	N/A
No	Refuge 2 X Slope (%)	N/A	N/A	Gutter 2 X Slope (%)	N/A
N/A	Painted X Walk2?	N/A	N/A	DWS 2 Provided?	N/A
N/A	X Walk 2 Direction	N/A	N/A	DWS 2 Contrast?	N/A
N/A	X Walk 2 Width (In)	N/A	N/A	DWS 2 Length (In)	N/A

N/A	Road 2 Slope (%)	N/A	N/A	DWS 2 Full Width?	N/A
N/A	Road 2 X Slope (%)	N/A	N/A	DWS 2 Offset (In)	N/A
N/A	Refuge 3 Length (in)	N/A	N/A	Gutter 3 Ponding?	N/A
N/A	Refuge 3 Width (in)	N/A	N/A	Gutter 3 Lip Ht (in)	N/A
N/A	Refuge 3 Slope (%)	N/A	N/A	Gutter 3 Slope (%)	N/A
N/A	Refuge 3 XSlope (%)	N/A	N/A	Gutter 3 XSlope (%)	N/A
N/A	Painted X Walk3?	N/A	N/A	DWS 3 Provided?	N/A
N/A	X Walk 3 Direction	N/A	N/A	DWS 3 Contrast?	N/A
N/A	X Walk 3 Width (in)	N/A	N/A	DWS 3 Length (in)	N/A
N/A	Road 3 Slope (%)	N/A	N/A	DWS 3 Full Width?	N/A
N/A	Road 3 XSlope (%)	N/A	N/A	DWS 3 Offset (in)	N/A
Yes	Any Obstructions?	N/A	N/A	Storm Grate/Utility Hazard?	N/A
N/A	Obstruction Type		N/A	Storm Grate/Utility Type	
		N/A			N/A
N/A	Surface Condition	Good

**Remove & Replace Entire Refuge.**

Total Cost: \$ 3000.00
