Access Compliance Report

Public Rights-of-Way

(Island Curb Cuts)

Intersection ID: 27040	Main Street: PIPER_GLEN_DR	Cross Street: REA_RD	Location:	N
ADA ID: 08A9724E6646	Curb Cut Type: MedianRefuge2	Initial Pass/Fail: Fail	Overall Compliance: No	Severity Score: 1.25
Codes/Mitigation Info/Possible Solution		Field Measurements/Component Compliance

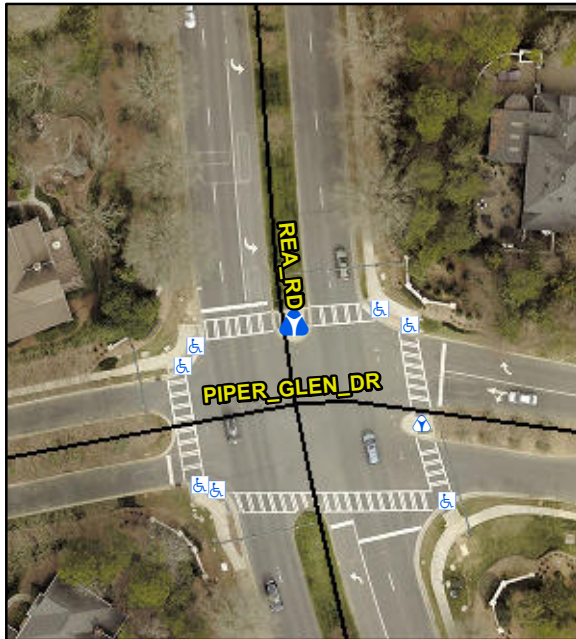
Compliance	Description	Data	Compliance	Description	Data
Yes	Refuge 1 Length (In)	107.0	N/A	Gutter 1 Ponding?	N/A
Yes	Refuge 1 Width (In)	93.0	N/A	Gutter 1 Lip Ht (In)	N/A
Yes	Refuge 1 Slope (%)	3.6	N/A	Gutter 1 Slope (%)	N/A
Yes	Refuge 1 X Slope (%)	2.6	N/A	Gutter 1 X Slope (%)	N/A
N/A	Painted X Walk1?	Yes	N/A	DWS 1 Provided?	N/A
N/A	X Walk 1 Direction	To E	N/A	DWS 1 Contrast?	N/A
N/A	X Walk 1 Width (In)	121.0	N/A	DWS 1 Length (In)	N/A
N/A	Road 1 Slope (%)	4.0	N/A	DWS 1 Full Width?	N/A
N/A	Road 1 X Slope (%)	3.0	N/A	DWS 1 Offset (In)	N/A
Yes	Refuge 2 Length (In)	107.0	N/A	Gutter 2 Ponding?	N/A
Yes	Refuge 2 Width (In)	93.0	N/A	Gutter 2 Lip Ht (In)	N/A
Yes	Refuge 2 Slope (%)	1.6	N/A	Gutter 2 Slope (%)	N/A
Yes	Refuge 2 X Slope (%)	1.2	N/A	Gutter 2 X Slope (%)	N/A
N/A	Painted X Walk2?	Yes	N/A	DWS 2 Provided?	N/A
N/A	X Walk 2 Direction	To W	N/A	DWS 2 Contrast?	N/A
N/A	X Walk 2 Width (In)	127.0	N/A	DWS 2 Length (In)	N/A

N/A	Road 2 Slope (%)	1.0	N/A	DWS 2 Full Width?	N/A
N/A	Road 2 X Slope (%)	4.7	N/A	DWS 2 Offset (In)	N/A
N/A	Refuge 3 Length (in)	N/A	N/A	Gutter 3 Ponding?	N/A
N/A	Refuge 3 Width (in)	N/A	N/A	Gutter 3 Lip Ht (in)	N/A
N/A	Refuge 3 Slope (%)	N/A	N/A	Gutter 3 Slope (%)	N/A
N/A	Refuge 3 XSlope (%)	N/A	N/A	Gutter 3 XSlope (%)	N/A
N/A	Painted X Walk3?	N/A	N/A	DWS 3 Provided?	N/A
N/A	X Walk 3 Direction	N/A	N/A	DWS 3 Contrast?	N/A
N/A	X Walk 3 Width (in)	N/A	N/A	DWS 3 Length (in)	N/A
N/A	Road 3 Slope (%)	N/A	N/A	DWS 3 Full Width?	N/A
N/A	Road 3 XSlope (%)	N/A	N/A	DWS 3 Offset (in)	N/A
Yes	Any Obstructions?	N/A	N/A	Storm Grate/Utility Hazard?	N/A
N/A	Obstruction Type		N/A	Storm Grate/Utility Type	
		N/A			N/A
N/A	Surface Condition	Good

Remove & Replace Entire Refuge.
