# Access Compliance Report

## Public Rights-of-Way

### (Island Curb Cuts)

Intersection ID: 13713	Main Street: UNIVERSITY POINTE BV	Cross Street: IBM DR	Location: W
ADA ID: 08AC6B1326D4	Curb Cut Type: MedianRefuge2	Initial Pass/Fail: Fail	Overall Compliance: No
Codes/Mitigation Info/Possible Solution		Field Measurements/Component Compliance	
Severity Score: 1.25

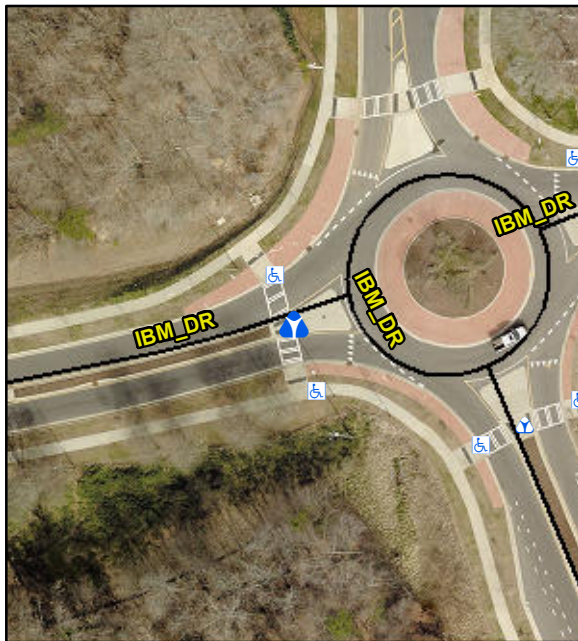
Compliance	Description	Data	Compliance	Description	Data
Yes	Refuge 1 Length (In)	38.0	N/A	Gutter 1 Ponding?	N/A
Yes	Refuge 1 Width (In)	120.0	N/A	Gutter 1 Lip Ht (In)	N/A
Yes	Refuge 1 Slope (%)	2.1	N/A	Gutter 1 Slope (%)	N/A
Yes	Refuge 1 X Slope (%)	3.0	N/A	Gutter 1 X Slope (%)	N/A
N/A	Painted X Walk1?	No	N/A	DWS 1 Provided?	N/A
N/A	X Walk 1 Direction	To S	N/A	DWS 1 Contrast?	N/A
N/A	X Walk 1 Width (In)	N/A	N/A	DWS 1 Length (In)	N/A
N/A	Road 1 Slope (%)	4.1	N/A	DWS 1 Full Width?	N/A
N/A	Road 1 X Slope (%)	2.3	N/A	DWS 1 Offset (In)	N/A
Yes	Refuge 2 Length (In)	38.0	N/A	Gutter 2 Ponding?	N/A
Yes	Refuge 2 Width (In)	120.0	N/A	Gutter 2 Lip Ht (In)	N/A
Yes	Refuge 2 Slope (%)	1.6	N/A	Gutter 2 Slope (%)	N/A
Yes	Refuge 2 X Slope (%)	4.5	N/A	Gutter 2 X Slope (%)	N/A
N/A	Painted X Walk2?	No	N/A	DWS 2 Provided?	N/A
N/A	X Walk 2 Direction	To N	N/A	DWS 2 Contrast?	N/A
N/A	X Walk 2 Width (In)	N/A	N/A	DWS 2 Length (In)	N/A

N/A	Road 2 Slope (%)	4.0	N/A	DWS 2 Full Width?	N/A
N/A	Road 2 X Slope (%)	2.5	N/A	DWS 2 Offset (In)	N/A
N/A	Refuge 3 Length (in)	N/A	N/A	Gutter 3 Ponding?	N/A
N/A	Refuge 3 Width (in)	N/A	N/A	Gutter 3 Lip Ht (in)	N/A
N/A	Refuge 3 Slope (%)	N/A	N/A	Gutter 3 Slope (%)	N/A
N/A	Refuge 3 XSlope (%)	N/A	N/A	Gutter 3 XSlope (%)	N/A
N/A	Painted X Walk3?	No	N/A	DWS 3 Provided?	N/A
N/A	X Walk 3 Direction	N/A	N/A	DWS 3 Contrast?	N/A
N/A	X Walk 3 Width (in)	N/A	N/A	DWS 3 Length (in)	N/A
N/A	Road 3 Slope (%)	N/A	N/A	DWS 3 Full Width?	N/A
N/A	Road 3 XSlope (%)	N/A	N/A	DWS 3 Offset (in)	N/A
Yes	Any Obstructions?	N/A	N/A	Storm Grate/Utility Hazard?	N/A
N/A	Obstruction Type		N/A	Storm Grate/Utility Type	
		N/A			N/A
N/A	Surface Condition	Good

**Remove & Replace Entire Refuge.**
