Access Compliance Report

Public Rights-of-Way

(Island Curb Cuts)

Intersection ID: 12669	Main Street: E_10TH_ST	Cross Street: STEVENS_ST	Location: E
ADA ID: 09EDAC941B67	Curb Cut Type: MedianRefuge2	Initial Pass/Fail: Fail	Overall Compliance: No
Severity Score: 12.5			
Codes/Mitigation Info/Possible Solution		Field Measurements/Component Compliance

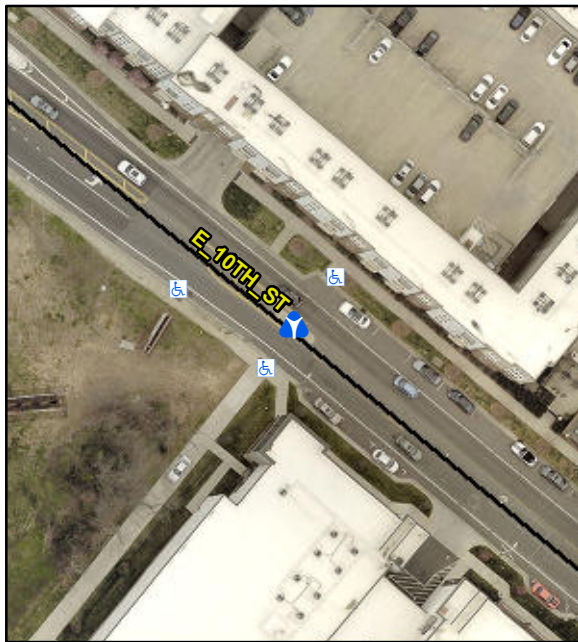
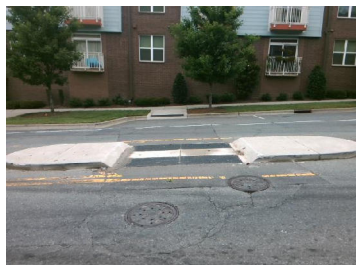
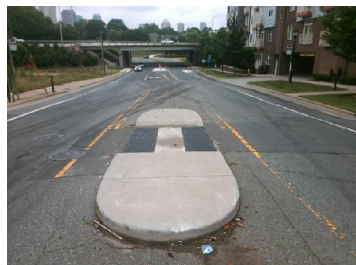
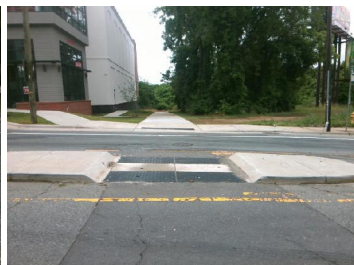
Compliance	Description	Data	Compliance	Description	Data
Yes	Refuge 1 Length (In)	36.0	N/A	Gutter 1 Ponding?	N/A
Yes	Refuge 1 Width (In)	103.0	N/A	Gutter 1 Lip Ht (In)	N/A
Yes	Refuge 1 Slope (%)	0.2	N/A	Gutter 1 Slope (%)	N/A
No	Refuge 1 X Slope (%)	5.3	N/A	Gutter 1 X Slope (%)	N/A
N/A	Painted X Walk1?	No	N/A	DWS 1 Provided?	N/A
N/A	X Walk 1 Direction	To SW	N/A	DWS 1 Contrast?	N/A
N/A	X Walk 1 Width (In)	N/A	N/A	DWS 1 Length (In)	N/A
N/A	Road 1 Slope (%)	4.5	N/A	DWS 1 Full Width?	N/A
N/A	Road 1 X Slope (%)	3.1	N/A	DWS 1 Offset (In)	N/A
Yes	Refuge 2 Length (In)	36.0	N/A	Gutter 2 Ponding?	N/A
Yes	Refuge 2 Width (In)	103.0	N/A	Gutter 2 Lip Ht (In)	N/A
Yes	Refuge 2 Slope (%)	0.4	N/A	Gutter 2 Slope (%)	N/A
Yes	Refuge 2 X Slope (%)	3.9	N/A	Gutter 2 X Slope (%)	N/A
N/A	Painted X Walk2?	No	N/A	DWS 2 Provided?	N/A
N/A	X Walk 2 Direction	To NE	N/A	DWS 2 Contrast?	N/A
N/A	X Walk 2 Width (In)	N/A	N/A	DWS 2 Length (In)	N/A

Remove & Replace Entire Refuge.

Total Cost: \$ 3000.00
