Access Compliance Report

Public Rights-of-Way

(Island Curb Cuts)

Intersection ID: 10952	Main Street: N_GRAHAM_ST	Cross Street: STATESVILLE_AV	Location: N
ADA ID: 09F93229E9BA	Curb Cut Type: MedianRefuge2	Initial Pass/Fail: Fail	Overall Compliance: No
Severity Score: 10			
Codes/Mitigation Info/Possible Solution		Field Measurements/Component Compliance

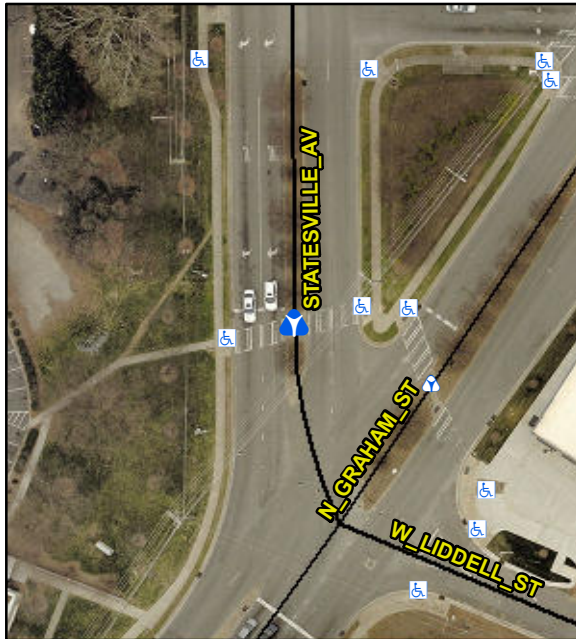
Compliance	Description	Data	Compliance	Description	Data
Yes	Refuge 1 Length (In)	53.0	N/A	Gutter 1 Ponding?	N/A
No	Refuge 1 Width (In)	48.5	N/A	Gutter 1 Lip Ht (In)	N/A
Yes	Refuge 1 Slope (%)	1.8	N/A	Gutter 1 Slope (%)	N/A
Yes	Refuge 1 X Slope (%)	0.7	N/A	Gutter 1 X Slope (%)	N/A
N/A	Painted X Walk1?	Yes	N/A	DWS 1 Provided?	N/A
N/A	X Walk 1 Direction	To E	N/A	DWS 1 Contrast?	N/A
N/A	X Walk 1 Width (In)	120.0	N/A	DWS 1 Length (In)	N/A
N/A	Road 1 Slope (%)	0.4	N/A	DWS 1 Full Width?	N/A
N/A	Road 1 X Slope (%)	2.6	N/A	DWS 1 Offset (In)	N/A
Yes	Refuge 2 Length (In)	53.0	N/A	Gutter 2 Ponding?	N/A
No	Refuge 2 Width (In)	48.5	N/A	Gutter 2 Lip Ht (In)	N/A
Yes	Refuge 2 Slope (%)	2.3	N/A	Gutter 2 Slope (%)	N/A
Yes	Refuge 2 X Slope (%)	1.2	N/A	Gutter 2 X Slope (%)	N/A
N/A	Painted X Walk2?	Yes	N/A	DWS 2 Provided?	N/A
N/A	X Walk 2 Direction	To W	N/A	DWS 2 Contrast?	N/A
N/A	X Walk 2 Width (In)	122.5	N/A	DWS 2 Length (In)	N/A

N/A	Road 2 Slope (%)	2.0	N/A	DWS 2 Full Width?	N/A
N/A	Road 2 X Slope (%)	2.7	N/A	DWS 2 Offset (In)	N/A
N/A	Refuge 3 Length (in)	N/A	N/A	Gutter 3 Ponding?	N/A
N/A	Refuge 3 Width (in)	N/A	N/A	Gutter 3 Lip Ht (in)	N/A
N/A	Refuge 3 Slope (%)	N/A	N/A	Gutter 3 Slope (%)	N/A
N/A	Refuge 3 XSlope (%)	N/A	N/A	Gutter 3 XSlope (%)	N/A
N/A	Painted X Walk3?	N/A	N/A	DWS 3 Provided?	N/A
N/A	X Walk 3 Direction	N/A	N/A	DWS 3 Contrast?	N/A
N/A	X Walk 3 Width (in)	N/A	N/A	DWS 3 Length (in)	N/A
N/A	Road 3 Slope (%)	N/A	N/A	DWS 3 Full Width?	N/A
N/A	Road 3 XSlope (%)	N/A	N/A	DWS 3 Offset (in)	N/A
Yes	Any Obstructions?	N/A	N/A	Storm Grate/Utility Hazard?	N/A
N/A	Obstruction Type		N/A	Storm Grate/Utility Type	
		N/A			N/A
N/A	Surface Condition	Good

Remove & Replace Entire Refuge.
