Access Compliance Report

Public Rights-of-Way

(Island Curb Cuts)

Intersection ID: 3559	Main Street: PERIMETER_PY	Cross Street: W_W_T_HARRIS_BV	Location: NE
ADA ID: 0B259B2538E3	Curb Cut Type: IslandRefuge3	Initial Pass/Fail: Fail	Overall Compliance: No
		Severity Score: 36.25

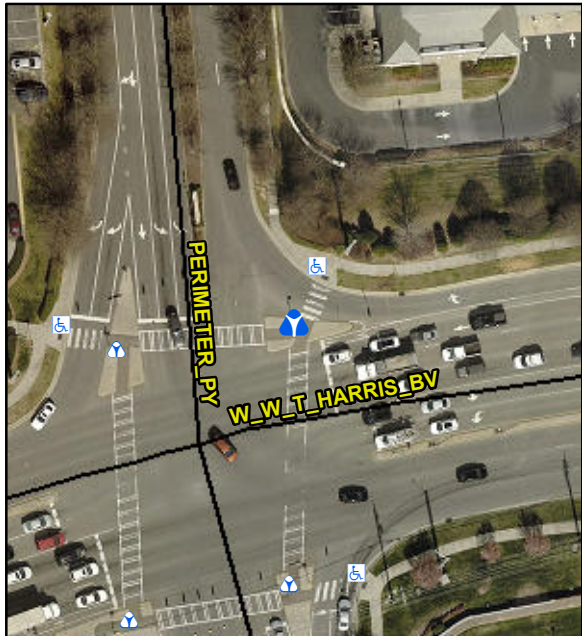
Possible Solutions:		Compliance	Description	Data	Compliance	Description	Data	
	Remove & Replace Entire Refuge.		Yes	Refuge 1 Length (In)	178.0	N/A	Gutter 1 Ponding?	N/A	
			Yes	Refuge 1 Width (In)	72.0	N/A	Gutter 1 Lip Ht (In)	N/A	
			Yes	Refuge 1 Slope (%)	2.5	N/A	Gutter 1 Slope (%)	N/A	
			Yes	Refuge 1 X Slope (%)	0.3	N/A	Gutter 1 X Slope (%)	N/A	
			N/A	Painted X Walk1?	Yes	N/A	DWS 1 Provided?	N/A	
	Surveyor Notes:		N/A	X Walk 1 Direction	To W	N/A	DWS 1 Contrast?	N/A	
		N/A		N/A	X Walk 1 Width (In)	120.0	N/A	DWS 1 Length (In)	N/A
				N/A	Road 1 Slope (%)	0.1	N/A	DWS 1 Full Width?	N/A
				N/A	Road 1 X Slope (%)	3.0	N/A	DWS 1 Offset (In)	N/A
PROW/ADA:				Yes	Refuge 2 Length (In)	61.0	N/A	Gutter 2 Ponding?	N/A
			Yes	Refuge 2 Width (In)	78.0	N/A	Gutter 2 Lip Ht (In)	N/A	
		Yes	Refuge 2 Slope (%)	0.6	N/A	Gutter 2 Slope (%)	N/A

Yes	Refuge 2 X Slope (%)	4.3	N/A	Gutter 2 X Slope (%)	N/A		
		N/A	Painted X Walk2?	Yes	N/A	DWS 2 Provided?	N/A		
		N/A	X Walk 2 Direction	To S	N/A	DWS 2 Contrast?	N/A		
		N/A	X Walk 2 Width (In)	110.0	N/A	DWS 2 Length (In)	N/A		
		N/A	Road 2 Slope (%)	2.2	N/A	DWS 2 Full Width?	N/A		
		N/A	Road 2 X Slope (%)	2.5	N/A	DWS 2 Offset (In)	N/A		
			Yes	Refuge 3 Length (in)	45.0	N/A	Gutter 3 Ponding?	N/A	
		Yes	Refuge 3 Width (in)	72.0	N/A	Gutter 3 Lip Ht (in)	N/A		
		Yes	Refuge 3 Slope (%)	1.1	N/A	Gutter 3 Slope (%)	N/A		
		Yes	Refuge 3 XSlope (%)	3.8	N/A	Gutter 3 XSlope (%)	N/A		
		N/A	Painted X Walk3?	Yes	N/A	DWS 3 Provided?	N/A		
		N/A	X Walk 3 Direction	To NE	N/A	DWS 3 Contrast?	N/A		
		N/A	X Walk 3 Width (in)	118.0	N/A	DWS 3 Length (in)	N/A		
		N/A	Road 3 Slope (%)	2.1	N/A	DWS 3 Full Width?	N/A		
		N/A	Road 3 XSlope (%)	0.9	N/A	DWS 3 Offset (in)	N/A		
		Yes	Any Obstructions?	N/A	N/A	Storm Grate/Utility Hazard?	N/A

N/A	Obstruction Type		N/A	Storm Grate/Utility Type			
					N/A		N/A		
		N/A	Surface Condition	Good
