# Access Compliance Report

## Public Rights-of-Way

### (Island Curb Cuts)

Intersection ID: 11838	Main Street: MECKLENBURG_AV	Cross Street: FORT_ST	Location:	N/A
ADA ID: 0BA4EDCDC6B7	Curb Cut Type: MedianRefuge2	Initial Pass/Fail: Fail	Overall Compliance: No	Severity Score: 13.75
Codes/Mitigation Info/Possible Solution		Field Measurements/Component Compliance

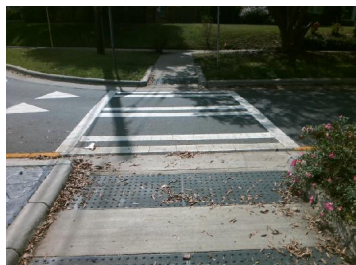
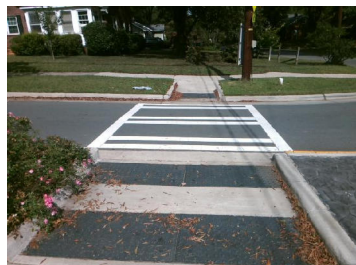
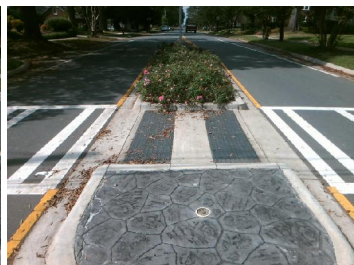
Compliance	Description	Data	Compliance	Description	Data
Yes	Refuge 1 Length (In)	39.0	N/A	Gutter 1 Ponding?	N/A
Yes	Refuge 1 Width (In)	95.0	N/A	Gutter 1 Lip Ht (In)	N/A
Yes	Refuge 1 Slope (%)	2.3	N/A	Gutter 1 Slope (%)	N/A
Yes	Refuge 1 X Slope (%)	2.3	N/A	Gutter 1 X Slope (%)	N/A
N/A	Painted X Walk1?	Yes	N/A	DWS 1 Provided?	N/A
N/A	X Walk 1 Direction	To S	N/A	DWS 1 Contrast?	N/A
N/A	X Walk 1 Width (In)	114.0	N/A	DWS 1 Length (In)	N/A
N/A	Road 1 Slope (%)	3.8	N/A	DWS 1 Full Width?	N/A
N/A	Road 1 X Slope (%)	1.2	N/A	DWS 1 Offset (In)	N/A
Yes	Refuge 2 Length (In)	39.0	N/A	Gutter 2 Ponding?	N/A
Yes	Refuge 2 Width (In)	95.0	N/A	Gutter 2 Lip Ht (In)	N/A
Yes	Refuge 2 Slope (%)	1.3	N/A	Gutter 2 Slope (%)	N/A
No	Refuge 2 X Slope (%)	5.2	N/A	Gutter 2 X Slope (%)	N/A
N/A	Painted X Walk2?	Yes	N/A	DWS 2 Provided?	N/A
N/A	X Walk 2 Direction	To N	N/A	DWS 2 Contrast?	N/A
N/A	X Walk 2 Width (In)	113.0	N/A	DWS 2 Length (In)	N/A

N/A	Road 2 Slope (%)	4.0	N/A	DWS 2 Full Width?	N/A
N/A	Road 2 X Slope (%)	1.3	N/A	DWS 2 Offset (In)	N/A
N/A	Refuge 3 Length (in)	N/A	N/A	Gutter 3 Ponding?	N/A
N/A	Refuge 3 Width (in)	N/A	N/A	Gutter 3 Lip Ht (in)	N/A
N/A	Refuge 3 Slope (%)	N/A	N/A	Gutter 3 Slope (%)	N/A
N/A	Refuge 3 XSlope (%)	N/A	N/A	Gutter 3 XSlope (%)	N/A
N/A	Painted X Walk3?	N/A	N/A	DWS 3 Provided?	N/A
N/A	X Walk 3 Direction	N/A	N/A	DWS 3 Contrast?	N/A
N/A	X Walk 3 Width (in)	N/A	N/A	DWS 3 Length (in)	N/A
N/A	Road 3 Slope (%)	N/A	N/A	DWS 3 Full Width?	N/A
N/A	Road 3 XSlope (%)	N/A	N/A	DWS 3 Offset (in)	N/A
Yes	Any Obstructions?	N/A	N/A	Storm Grate/Utility Hazard?	N/A
N/A	Obstruction Type		N/A	Storm Grate/Utility Type	
		N/A			N/A
N/A	Surface Condition	Good

**Remove & Replace Entire Refuge.**
