Access Compliance Report

Public Rights-of-Way

(Island Curb Cuts)

Intersection ID: 10020374	Main Street: BALLANTYNE CORPORATE PCross Street: N/A	Location: SE
ADA ID: 0C278FD85C65	Curb Cut Type: MedianRefuge2	Initial Pass/Fail: Fail
	Overall Compliance: No	Severity Score: 1.25
Codes/Mitigation Info/Possible Solution		Field Measurements/Component Compliance

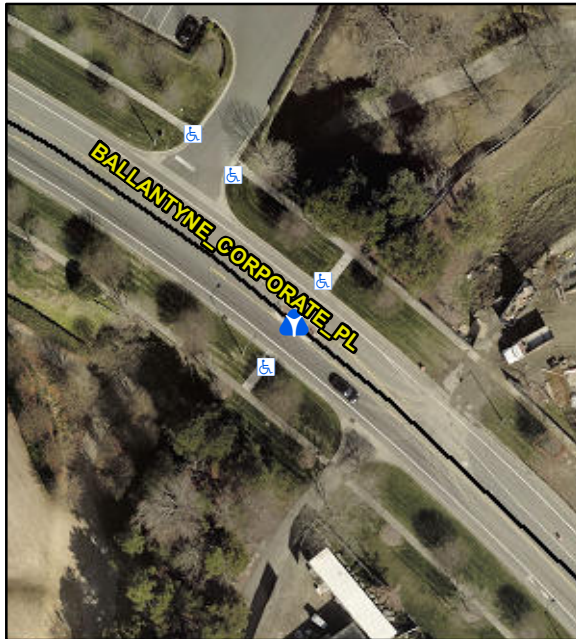
Compliance	Description	Data	Compliance	Description	Data
Yes	Refuge 1 Length (In)	60.5	N/A	Gutter 1 Ponding?	N/A
Yes	Refuge 1 Width (In)	100.0	N/A	Gutter 1 Lip Ht (In)	N/A
Yes	Refuge 1 Slope (%)	3.2	N/A	Gutter 1 Slope (%)	N/A
Yes	Refuge 1 X Slope (%)	2.8	N/A	Gutter 1 X Slope (%)	N/A
N/A	Painted X Walk1?	No	N/A	DWS 1 Provided?	N/A
N/A	X Walk 1 Direction	To SW	N/A	DWS 1 Contrast?	N/A
N/A	X Walk 1 Width (In)	N/A	N/A	DWS 1 Length (In)	N/A
N/A	Road 1 Slope (%)	1.3	N/A	DWS 1 Full Width?	N/A
N/A	Road 1 X Slope (%)	4.9	N/A	DWS 1 Offset (In)	N/A
Yes	Refuge 2 Length (In)	60.5	N/A	Gutter 2 Ponding?	N/A
Yes	Refuge 2 Width (In)	100.0	N/A	Gutter 2 Lip Ht (In)	N/A
Yes	Refuge 2 Slope (%)	2.9	N/A	Gutter 2 Slope (%)	N/A
Yes	Refuge 2 X Slope (%)	3.1	N/A	Gutter 2 X Slope (%)	N/A
N/A	Painted X Walk2?	No	N/A	DWS 2 Provided?	N/A
N/A	X Walk 2 Direction	To NE	N/A	DWS 2 Contrast?	N/A
N/A	X Walk 2 Width (In)	N/A	N/A	DWS 2 Length (In)	N/A

N/A	Road 2 Slope (%)	2.3	N/A	DWS 2 Full Width?	N/A
N/A	Road 2 X Slope (%)	5.1	N/A	DWS 2 Offset (In)	N/A
N/A	Refuge 3 Length (in)	N/A	N/A	Gutter 3 Ponding?	N/A
N/A	Refuge 3 Width (in)	N/A	N/A	Gutter 3 Lip Ht (in)	N/A
N/A	Refuge 3 Slope (%)	N/A	N/A	Gutter 3 Slope (%)	N/A
N/A	Refuge 3 XSlope (%)	N/A	N/A	Gutter 3 XSlope (%)	N/A
N/A	Painted X Walk3?	N/A	N/A	DWS 3 Provided?	N/A
N/A	X Walk 3 Direction	N/A	N/A	DWS 3 Contrast?	N/A
N/A	X Walk 3 Width (in)	N/A	N/A	DWS 3 Length (in)	N/A
N/A	Road 3 Slope (%)	N/A	N/A	DWS 3 Full Width?	N/A
N/A	Road 3 XSlope (%)	N/A	N/A	DWS 3 Offset (in)	N/A
Yes	Any Obstructions?	N/A	N/A	Storm Grate/Utility Hazard?	N/A
N/A	Obstruction Type		N/A	Storm Grate/Utility Type	
		N/A			N/A
N/A	Surface Condition	Good

Possible Solutions:

Remove & Replace Entire Refuge.
