# Access Compliance Report

## Public Rights-of-Way

### (Island Curb Cuts)

Intersection ID: 21312	Main Street: E_ARROWWOOD_RD	Cross Street: SOUTH_BV	Location: SW
ADA ID: 0D40B9213E9D	Curb Cut Type: IslandRefuge3	Initial Pass/Fail: Fail	Overall Compliance: No
Severity Score: 35			
Codes/Mitigation Info/Possible Solution		Field Measurements/Component Compliance

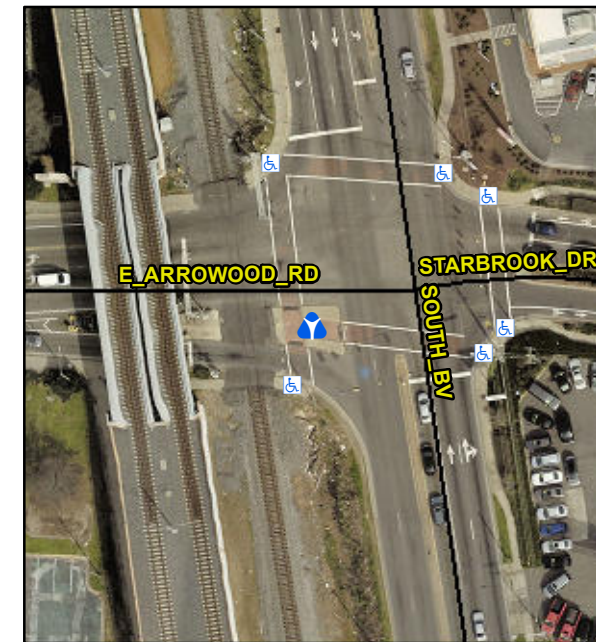
Compliance	Description	Data	Compliance	Description	Data
Yes	Refuge 1 Length (In)	119.0	N/A	Gutter 1 Ponding?	N/A
Yes	Refuge 1 Width (In)	120.0	N/A	Gutter 1 Lip Ht (In)	N/A
Yes	Refuge 1 Slope (%)	1.3	N/A	Gutter 1 Slope (%)	N/A
Yes	Refuge 1 X Slope (%)	2.7	N/A	Gutter 1 X Slope (%)	N/A
N/A	Painted X Walk1?	Yes	N/A	DWS 1 Provided?	N/A
N/A	X Walk 1 Direction	To N	N/A	DWS 1 Contrast?	N/A
N/A	X Walk 1 Width (In)	128.0	N/A	DWS 1 Length (In)	N/A
N/A	Road 1 Slope (%)	3.0	N/A	DWS 1 Full Width?	N/A
N/A	Road 1 X Slope (%)	1.5	N/A	DWS 1 Offset (In)	N/A
Yes	Refuge 2 Length (In)	119.0	N/A	Gutter 2 Ponding?	N/A
Yes	Refuge 2 Width (In)	120.0	N/A	Gutter 2 Lip Ht (In)	N/A
Yes	Refuge 2 Slope (%)	0.7	N/A	Gutter 2 Slope (%)	N/A
Yes	Refuge 2 X Slope (%)	2.2	N/A	Gutter 2 X Slope (%)	N/A
N/A	Painted X Walk2?	Yes	N/A	DWS 2 Provided?	N/A
N/A	X Walk 2 Direction	To S	N/A	DWS 2 Contrast?	N/A
N/A	X Walk 2 Width (In)	128.0	N/A	DWS 2 Length (In)	N/A

N/A	Road 2 Slope (%)	4.9	N/A	DWS 2 Full Width?	N/A
N/A	Road 2 X Slope (%)	0.6	N/A	DWS 2 Offset (In)	N/A
Yes	Refuge 3 Length (in)	223.0	N/A	Gutter 3 Ponding?	N/A
Yes	Refuge 3 Width (in)	125.0	N/A	Gutter 3 Lip Ht (in)	N/A
Yes	Refuge 3 Slope (%)	0.0	N/A	Gutter 3 Slope (%)	N/A
Yes	Refuge 3 XSlope (%)	2.0	N/A	Gutter 3 XSlope (%)	N/A
N/A	Painted X Walk3?	Yes	N/A	DWS 3 Provided?	N/A
N/A	X Walk 3 Direction	To E	N/A	DWS 3 Contrast?	N/A
N/A	X Walk 3 Width (in)	120.0	N/A	DWS 3 Length (in)	N/A
N/A	Road 3 Slope (%)	0.5	N/A	DWS 3 Full Width?	N/A
N/A	Road 3 XSlope (%)	2.2	N/A	DWS 3 Offset (in)	N/A
Yes	Any Obstructions?	N/A	N/A	Storm Grate/Utility Hazard?	N/A
N/A	Obstruction Type		N/A	Storm Grate/Utility Type	
			N/A		N/A
N/A	Surface Condition	Good

Possible Solutions:

**Remove & Replace Entire Refuge.**
