# Access Compliance Report

## Public Rights-of-Way

### (Island Curb Cuts)

Intersection ID: 10025976	Main Street: ELM_LN	Cross Street: N/A	Location:	W
ADA ID: 0D5016DFBD6E	Curb Cut Type: MedianRefuge2	Initial Pass/Fail: Fail	Overall Compliance: No	Severity Score: 0
Codes/Mitigation Info/Possible Solution		Field Measurements/Component Compliance

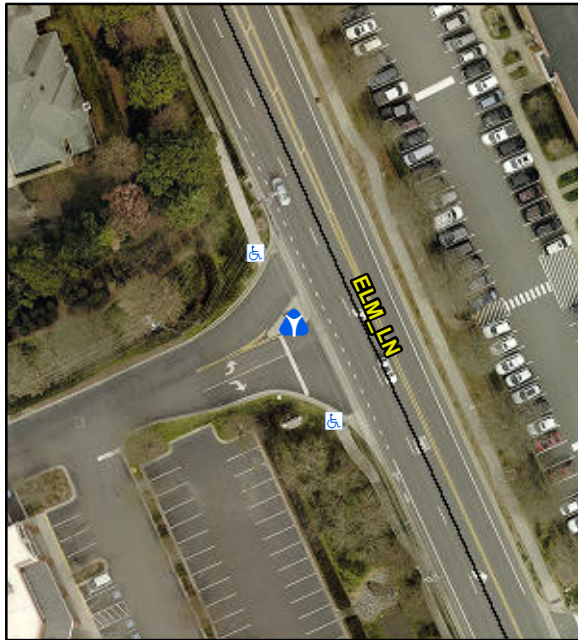
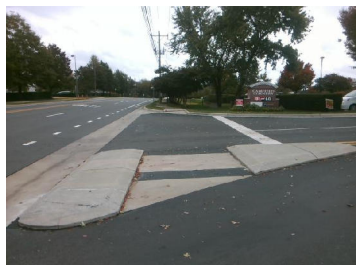
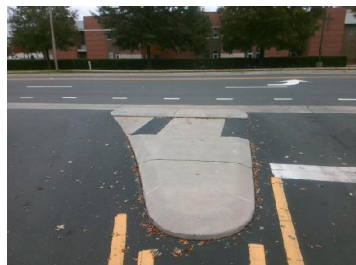
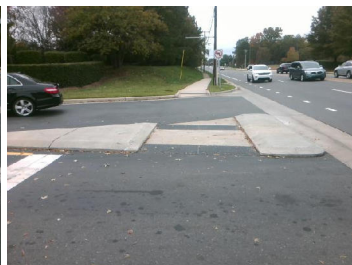
Compliance	Description	Data	Compliance	Description	Data
Yes	Refuge 1 Length (In)	54.0	N/A	Gutter 1 Ponding?	N/A
Yes	Refuge 1 Width (In)	95.5	N/A	Gutter 1 Lip Ht (In)	N/A
Yes	Refuge 1 Slope (%)	0.8	N/A	Gutter 1 Slope (%)	N/A
Yes	Refuge 1 X Slope (%)	3.9	N/A	Gutter 1 X Slope (%)	N/A
N/A	Painted X Walk1?	No	N/A	DWS 1 Provided?	N/A
N/A	X Walk 1 Direction	To NW	N/A	DWS 1 Contrast?	N/A
N/A	X Walk 1 Width (In)	N/A	N/A	DWS 1 Length (In)	N/A
N/A	Road 1 Slope (%)	4.9	N/A	DWS 1 Full Width?	N/A
N/A	Road 1 X Slope (%)	1.2	N/A	DWS 1 Offset (In)	N/A
Yes	Refuge 2 Length (In)	54.0	N/A	Gutter 2 Ponding?	N/A
Yes	Refuge 2 Width (In)	95.5	N/A	Gutter 2 Lip Ht (In)	N/A
Yes	Refuge 2 Slope (%)	0.7	N/A	Gutter 2 Slope (%)	N/A
Yes	Refuge 2 X Slope (%)	3.7	N/A	Gutter 2 X Slope (%)	N/A
N/A	Painted X Walk2?	No	N/A	DWS 2 Provided?	N/A
N/A	X Walk 2 Direction	To SE	N/A	DWS 2 Contrast?	N/A
N/A	X Walk 2 Width (In)	N/A	N/A	DWS 2 Length (In)	N/A

N/A	Road 2 Slope (%)	3.6	N/A	DWS 2 Full Width?	N/A
N/A	Road 2 X Slope (%)	1.8	N/A	DWS 2 Offset (In)	N/A
N/A	Refuge 3 Length (in)	N/A	N/A	Gutter 3 Ponding?	N/A
N/A	Refuge 3 Width (in)	N/A	N/A	Gutter 3 Lip Ht (in)	N/A
N/A	Refuge 3 Slope (%)	N/A	N/A	Gutter 3 Slope (%)	N/A
N/A	Refuge 3 XSlope (%)	N/A	N/A	Gutter 3 XSlope (%)	N/A
N/A	Painted X Walk3?	N/A	N/A	DWS 3 Provided?	N/A
N/A	X Walk 3 Direction	N/A	N/A	DWS 3 Contrast?	N/A
N/A	X Walk 3 Width (in)	N/A	N/A	DWS 3 Length (in)	N/A
N/A	Road 3 Slope (%)	N/A	N/A	DWS 3 Full Width?	N/A
N/A	Road 3 XSlope (%)	N/A	N/A	DWS 3 Offset (in)	N/A
Yes	Any Obstructions?	N/A	N/A	Storm Grate/Utility Hazard?	N/A
N/A	Obstruction Type		N/A	Storm Grate/Utility Type	
		N/A			N/A
N/A	Surface Condition	Good

**Remove & Replace Entire Refuge.**
