# Access Compliance Report

## Public Rights-of-Way

### (Island Curb Cuts)

Intersection ID: 5714	Main Street: JOHN_KIRK_DR	Cross Street: UNIVERSITY_CITY_BV	Location:	N
ADA ID: 0E472E20218A	Curb Cut Type: MedianRefuge2	Initial Pass/Fail: Fail	Overall Compliance: No	Severity Score: 25
Codes/Mitigation Info/Possible Solution		Field Measurements/Component Compliance

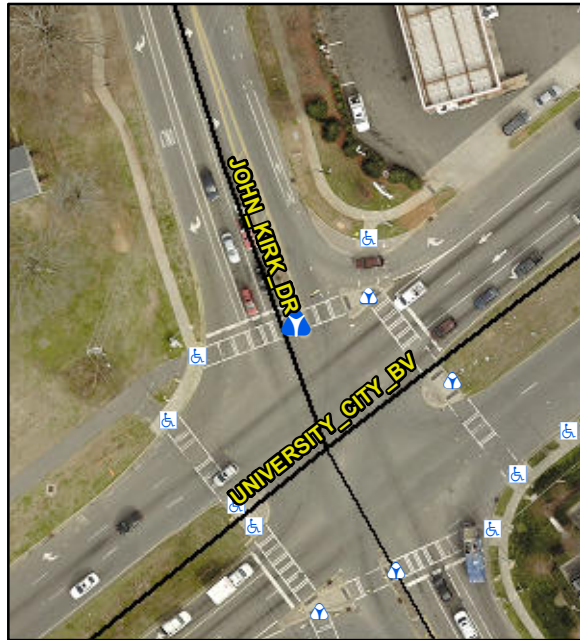
Compliance	Description	Data	Compliance	Description	Data
Yes	Refuge 1 Length (In)	36.0	N/A	Gutter 1 Ponding?	N/A
Yes	Refuge 1 Width (In)	97.0	N/A	Gutter 1 Lip Ht (In)	N/A
No	Refuge 1 Slope (%)	7.0	N/A	Gutter 1 Slope (%)	N/A
Yes	Refuge 1 X Slope (%)	1.6	N/A	Gutter 1 X Slope (%)	N/A
N/A	Painted X Walk1?	Yes	N/A	DWS 1 Provided?	N/A
N/A	X Walk 1 Direction	To W	N/A	DWS 1 Contrast?	N/A
N/A	X Walk 1 Width (In)	109.0	N/A	DWS 1 Length (In)	N/A
N/A	Road 1 Slope (%)	1.1	N/A	DWS 1 Full Width?	N/A
N/A	Road 1 X Slope (%)	1.0	N/A	DWS 1 Offset (In)	N/A
Yes	Refuge 2 Length (In)	36.0	N/A	Gutter 2 Ponding?	N/A
Yes	Refuge 2 Width (In)	97.0	N/A	Gutter 2 Lip Ht (In)	N/A
No	Refuge 2 Slope (%)	5.1	N/A	Gutter 2 Slope (%)	N/A
Yes	Refuge 2 X Slope (%)	0.7	N/A	Gutter 2 X Slope (%)	N/A
N/A	Painted X Walk2?	Yes	N/A	DWS 2 Provided?	N/A
N/A	X Walk 2 Direction	To E	N/A	DWS 2 Contrast?	N/A
N/A	X Walk 2 Width (In)	109.0	N/A	DWS 2 Length (In)	N/A

**Remove & Replace Entire Refuge.**
