Access Compliance Report

Public Rights-of-Way

(Island Curb Cuts)

| Intersection ID: 10180 | Main Street: FERN_AV | Cross Street: TUCKASEEGEE_RD | Location: N |

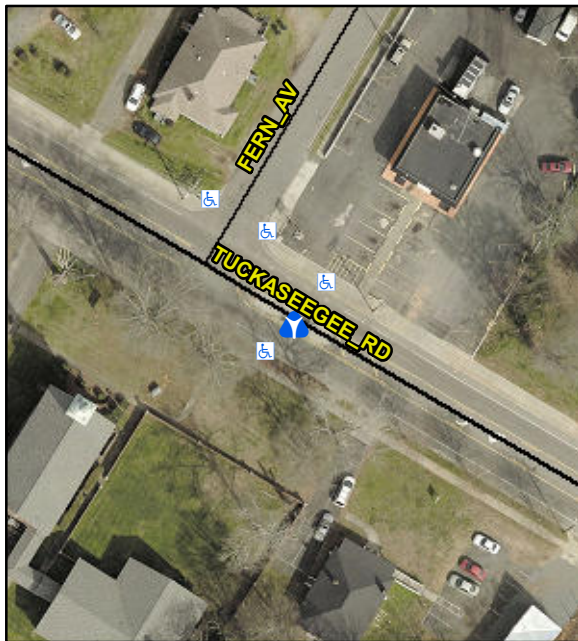
| ADA ID: 0FBC3A7DFBF0 | Curb Cut Type: MedianRefuge2 | Initial Pass/Fail: Fail | Overall Compliance: No |

Possible Solutions:

Remove & Replace Entire Refuge.

Total Cost:

\$ 3000.00
