# Access Compliance Report

## Public Rights-of-Way

### (Island Curb Cuts)

| Intersection ID: 11331 | Main Street: E_W_T_HARRIS_BV | Cross Street: MEADOW_ROSE_LN | Location: NW |

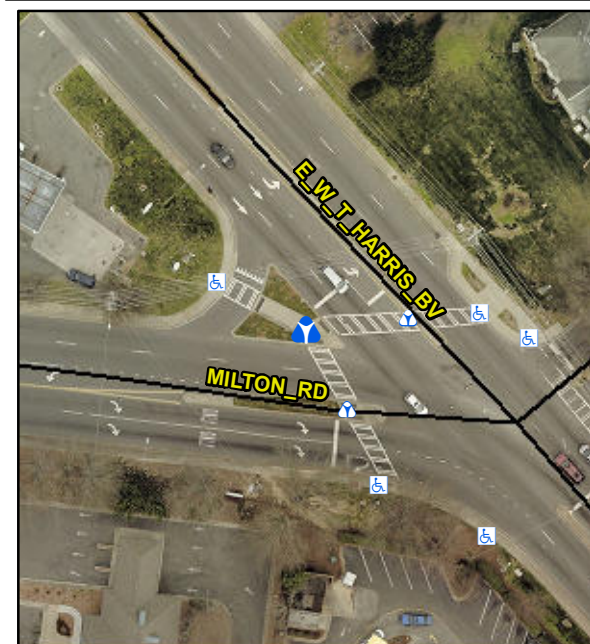
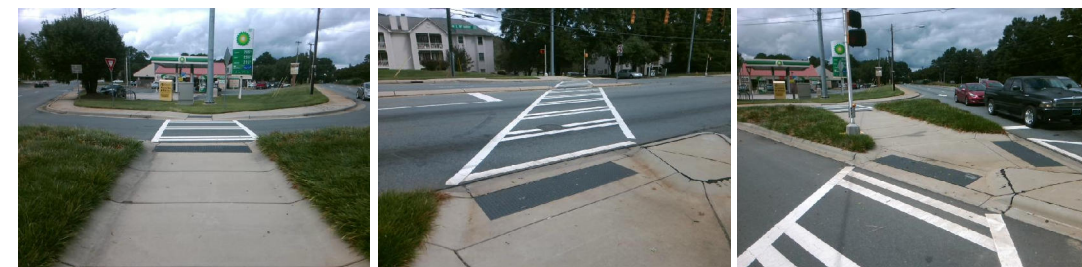
| Compliance | Description | Data | Compliance | Description | Data |
|---|---|---|---|---|---|
| Yes | Refuge 1 Length (In) | 356.0 | No | Gutter 1 Ponding? | Yes |
| Yes | Refuge 1 Width (In) | 96.5 | No | Gutter 1 Lip Ht (In) | 0.25 |
| Yes | Refuge 2 Length (In) | 42.5 | No | Gutter 2 Ponding? | Yes |
| Yes | Refuge 2 Width (In) | 118.0 | No | Gutter 2 Lip Ht (In) | 0.5 |
| Yes | Refuge 3 Length (in) | 41.0 | No | Gutter 3 Ponding? | Yes |
| Yes | Refuge 3 Width (in) | 120.0 | No | Gutter 3 Lip Ht (in) | 0.25 |

**Grind Gutter Lip.**

Total Cost: \$ 600.00
