Access Compliance Report

Public Rights-of-Way

(Island Curb Cuts)

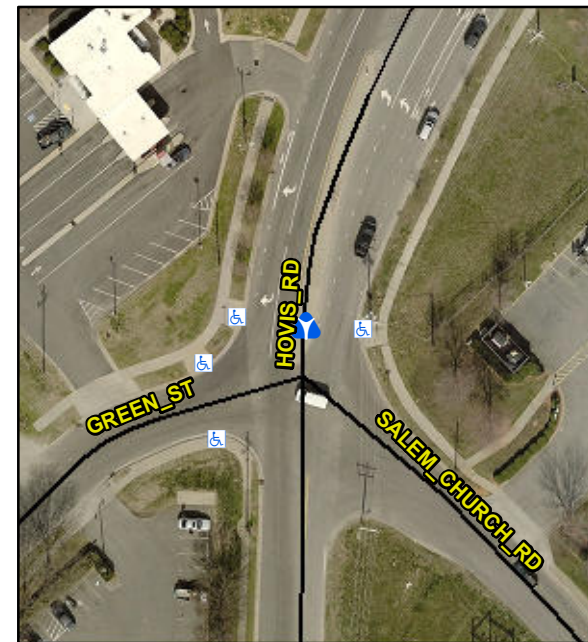
Intersection ID: 43188	Main Street: HOVIS_RD	Cross Street: SALEM_CHURCH_RD	Location:	N
ADA ID: 100D705250C2	Curb Cut Type: MedianRefuge2	Initial Pass/Fail: Pass	Overall Compliance: No	Severity Score: 10.25
Codes/Mitigation Info/Possible Solution		Field Measurements/Component Compliance

Compliance	Description	Data	Compliance	Description	Data
Yes	Refuge 1 Length (In)	53.5	No	Gutter 1 Ponding?	Yes
Yes	Refuge 1 Width (In)	95.0	Yes	Gutter 1 Lip Ht (In)	0.0
Yes	Refuge 1 Slope (%)	0.1	Yes	Gutter 1 Slope (%)	2.3
Yes	Refuge 1 X Slope (%)	0.9	Yes	Gutter 1 X Slope (%)	0.5
N/A	Painted X Walk1?	No	Yes	DWS 1 Provided?	Yes
N/A	X Walk 1 Direction	To W	Yes	DWS 1 Contrast?	Yes
N/A	X Walk 1 Width (In)	N/A	Yes	DWS 1 Length (In)	24.0
N/A	Road 1 Slope (%)	0.7	Yes	DWS 1 Full Width?	Yes
N/A	Road 1 X Slope (%)	0.1	No	DWS 1 Offset (In)	9.0
Yes	Refuge 2 Length (In)	53.5	Yes	Gutter 2 Ponding?	No
Yes	Refuge 2 Width (In)	95.0	Yes	Gutter 2 Lip Ht (In)	0.0
Yes	Refuge 2 Slope (%)	3.3	No	Gutter 2 Slope (%)	5.9
Yes	Refuge 2 X Slope (%)	0.5	Yes	Gutter 2 X Slope (%)	0.3
N/A	Painted X Walk2?	No	Yes	DWS 2 Provided?	Yes
N/A	X Walk 2 Direction	To E	Yes	DWS 2 Contrast?	Yes
N/A	X Walk 2 Width (In)	N/A	Yes	DWS 2 Length (In)	24.0

N/A	Road 2 Slope (%)	0.1	Yes	DWS 2 Full Width?	Yes
N/A	Road 2 X Slope (%)	4.9	No	DWS 2 Offset (In)	2.5
N/A	Refuge 3 Length (in)	N/A	N/A	Gutter 3 Ponding?	N/A
N/A	Refuge 3 Width (in)	N/A	N/A	Gutter 3 Lip Ht (in)	N/A
N/A	Refuge 3 Slope (%)	N/A	N/A	Gutter 3 Slope (%)	N/A
N/A	Refuge 3 XSlope (%)	N/A	N/A	Gutter 3 XSlope (%)	N/A
N/A	Painted X Walk3?	N/A	N/A	DWS 3 Provided?	N/A
N/A	X Walk 3 Direction	N/A	N/A	DWS 3 Contrast?	N/A
N/A	X Walk 3 Width (in)	N/A	N/A	DWS 3 Length (in)	N/A
N/A	Road 3 Slope (%)	N/A	N/A	DWS 3 Full Width?	N/A
N/A	Road 3 XSlope (%)	N/A	N/A	DWS 3 Offset (in)	N/A
Yes	Any Obstructions?	No	N/A	Storm Grate/Utility Hazard?	No
N/A	Obstruction Type		N/A	Storm Grate/Utility Type	
		N/A			N/A
N/A	Surface Condition	Good

Remove & Replace Detectable Warning System. Fix Gutter Ponding. Remove & Replace Gutter.
