# Access Compliance Report

## Public Rights-of-Way

### (Island Curb Cuts)

Intersection ID: 4530	Main Street: BROOKSHIRE_BV	Cross Street: MT_HOLLY-HUNTERSVILLE_RD	Location: NW
ADA ID: 10FCD7499003	Curb Cut Type: MedianRefuge2	Initial Pass/Fail: Pass	Overall Compliance: No
Codes/Mitigation Info/Possible Solution		Field Measurements/Component Compliance	
Severity Score: 0

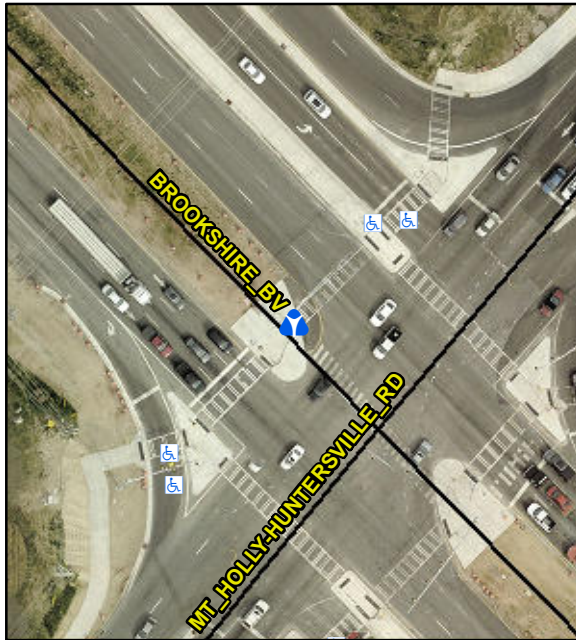
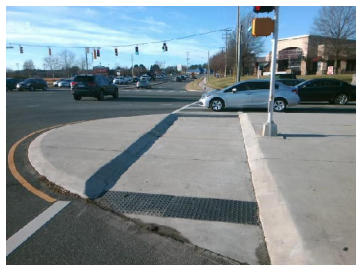
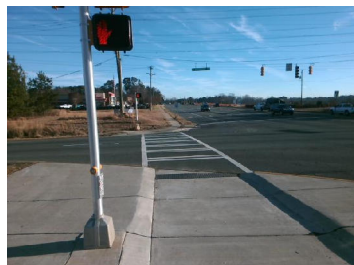
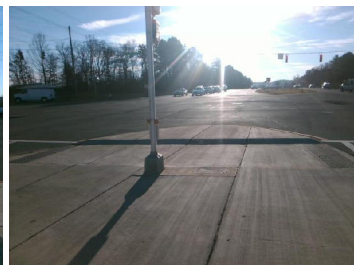
Compliance	Description	Data	Compliance	Description	Data
Yes	Refuge 1 Length (In)	153.5	Yes	Gutter 1 Ponding?	No
Yes	Refuge 1 Width (In)	97.0	Yes	Gutter 1 Lip Ht (In)	0.0
Yes	Refuge 1 Slope (%)	0.9	Yes	Gutter 1 Slope (%)	0.9
Yes	Refuge 1 X Slope (%)	0.7	Yes	Gutter 1 X Slope (%)	0.1
N/A	Painted X Walk1?	Yes	Yes	DWS 1 Provided?	Yes
N/A	X Walk 1 Direction	To SW	Yes	DWS 1 Contrast?	Yes
N/A	X Walk 1 Width (In)	111.0	Yes	DWS 1 Length (In)	24.0
N/A	Road 1 Slope (%)	1.0	Yes	DWS 1 Full Width?	Yes
N/A	Road 1 X Slope (%)	0.0	No	DWS 1 Offset (In)	7.0
Yes	Refuge 2 Length (In)	153.5	Yes	Gutter 2 Ponding?	No
Yes	Refuge 2 Width (In)	97.0	Yes	Gutter 2 Lip Ht (In)	0.0
Yes	Refuge 2 Slope (%)	1.4	Yes	Gutter 2 Slope (%)	1.4
Yes	Refuge 2 X Slope (%)	1.5	Yes	Gutter 2 X Slope (%)	0.9
N/A	Painted X Walk2?	Yes	Yes	DWS 2 Provided?	Yes
N/A	X Walk 2 Direction	To NE	Yes	DWS 2 Contrast?	Yes
N/A	X Walk 2 Width (In)	110.0	Yes	DWS 2 Length (In)	24.0

N/A	Road 2 Slope (%)	1.5	Yes	DWS 2 Full Width?	Yes
N/A	Road 2 X Slope (%)	1.4	No	DWS 2 Offset (In)	30.0
N/A	Refuge 3 Length (in)	N/A	N/A	Gutter 3 Ponding?	N/A
N/A	Refuge 3 Width (in)	N/A	N/A	Gutter 3 Lip Ht (in)	N/A
N/A	Refuge 3 Slope (%)	N/A	N/A	Gutter 3 Slope (%)	N/A
N/A	Refuge 3 XSlope (%)	N/A	N/A	Gutter 3 XSlope (%)	N/A
N/A	Painted X Walk3?	N/A	N/A	DWS 3 Provided?	N/A
N/A	X Walk 3 Direction	N/A	N/A	DWS 3 Contrast?	N/A
N/A	X Walk 3 Width (in)	N/A	N/A	DWS 3 Length (in)	N/A
N/A	Road 3 Slope (%)	N/A	N/A	DWS 3 Full Width?	N/A
N/A	Road 3 XSlope (%)	N/A	N/A	DWS 3 Offset (in)	N/A
Yes	Any Obstructions?	No	N/A	Storm Grate/Utility Hazard?	No
N/A	Obstruction Type		N/A	Storm Grate/Utility Type	
N/A	Surface Condition	Good	N/A		N/A

**Remove & Replace Detectable Warning System.**
