Access Compliance Report

Public Rights-of-Way

(Island Curb Cuts)

Intersection ID: 47611	Main Street: WYALONG_DR	Cross Street: MINTWORTH_AV	Location: SW
ADA ID: 1147B7287202	Curb Cut Type: MedianRefuge2	Initial Pass/Fail: Fail	Overall Compliance: No
Codes/Mitigation Info/Possible Solution		Field Measurements/Component Compliance

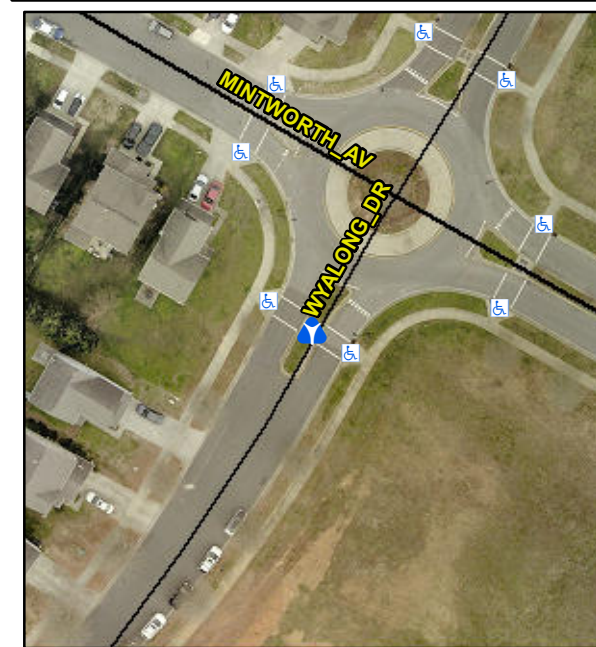
Compliance	Description	Data	Compliance	Description	Data
Yes	Refuge 1 Length (In)	51.0	N/A	Gutter 1 Ponding?	N/A
No	Refuge 1 Width (In)	49.0	N/A	Gutter 1 Lip Ht (In)	N/A
Yes	Refuge 1 Slope (%)	1.1	N/A	Gutter 1 Slope (%)	N/A
No	Refuge 1 X Slope (%)	5.2	N/A	Gutter 1 X Slope (%)	N/A
N/A	Painted X Walk1?	Yes	N/A	DWS 1 Provided?	N/A
N/A	X Walk 1 Direction	To SE	N/A	DWS 1 Contrast?	N/A
N/A	X Walk 1 Width (In)	119.0	N/A	DWS 1 Length (In)	N/A
N/A	Road 1 Slope (%)	2.1	N/A	DWS 1 Full Width?	N/A
N/A	Road 1 X Slope (%)	2.7	N/A	DWS 1 Offset (In)	N/A
Yes	Refuge 2 Length (In)	51.0	N/A	Gutter 2 Ponding?	N/A
No	Refuge 2 Width (In)	49.0	N/A	Gutter 2 Lip Ht (In)	N/A
Yes	Refuge 2 Slope (%)	0.1	N/A	Gutter 2 Slope (%)	N/A
Yes	Refuge 2 X Slope (%)	3.9	N/A	Gutter 2 X Slope (%)	N/A
N/A	Painted X Walk2?	Yes	N/A	DWS 2 Provided?	N/A
N/A	X Walk 2 Direction	To NW	N/A	DWS 2 Contrast?	N/A
N/A	X Walk 2 Width (In)	119.0	N/A	DWS 2 Length (In)	N/A

Remove & Replace Entire Refuge.
