Access Compliance Report

Public Rights-of-Way

(Island Curb Cuts)

Intersection ID: 17772	Main Street: IDLEWILD_RD	Cross Street: VALLEY_GROVE_RD	Location: SE
ADA ID: 1459B65D0C0B	Curb Cut Type: MedianRefuge2	Initial Pass/Fail: Fail	Overall Compliance: No
Codes/Mitigation Info/Possible Solution		Field Measurements/Component Compliance	
Severity Score: 25

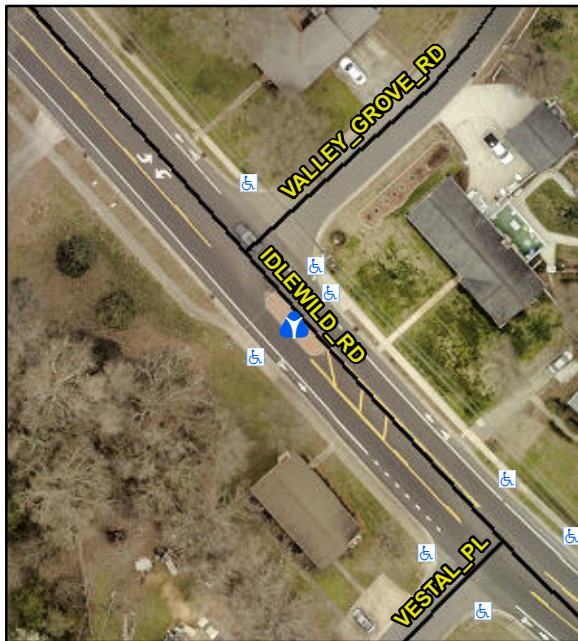
Compliance	Description	Data	Compliance	Description	Data
Yes	Refuge 1 Length (In)	65.0	N/A	Gutter 1 Ponding?	N/A
Yes	Refuge 1 Width (In)	121.0	N/A	Gutter 1 Lip Ht (In)	N/A
No	Refuge 1 Slope (%)	5.8	N/A	Gutter 1 Slope (%)	N/A
Yes	Refuge 1 X Slope (%)	4.9	N/A	Gutter 1 X Slope (%)	N/A
N/A	Painted X Walk1?	No	N/A	DWS 1 Provided?	N/A
N/A	X Walk 1 Direction	To NE	N/A	DWS 1 Contrast?	N/A
N/A	X Walk 1 Width (In)	N/A	N/A	DWS 1 Length (In)	N/A
N/A	Road 1 Slope (%)	3.8	N/A	DWS 1 Full Width?	N/A
N/A	Road 1 X Slope (%)	6.2	N/A	DWS 1 Offset (In)	N/A
Yes	Refuge 2 Length (In)	65.0	N/A	Gutter 2 Ponding?	N/A
Yes	Refuge 2 Width (In)	121.0	N/A	Gutter 2 Lip Ht (In)	N/A
Yes	Refuge 2 Slope (%)	1.5	N/A	Gutter 2 Slope (%)	N/A
No	Refuge 2 X Slope (%)	5.3	N/A	Gutter 2 X Slope (%)	N/A
N/A	Painted X Walk2?	No	N/A	DWS 2 Provided?	N/A
N/A	X Walk 2 Direction	To SW	N/A	DWS 2 Contrast?	N/A
N/A	X Walk 2 Width (In)	N/A	N/A	DWS 2 Length (In)	N/A

Remove & Replace Entire Refuge.
