# Access Compliance Report

## Public Rights-of-Way

### (Island Curb Cuts)

Intersection ID: 15766	Main Street: KENILWORTH_AV	Cross Street: PARK_RD	Location:	N/A
ADA ID: 165C6A46D611	Curb Cut Type: IslandRefuge3	Initial Pass/Fail: Fail	Overall Compliance: No	Severity Score: 47.5
Codes/Mitigation Info/Possible Solution		Field Measurements/Component Compliance

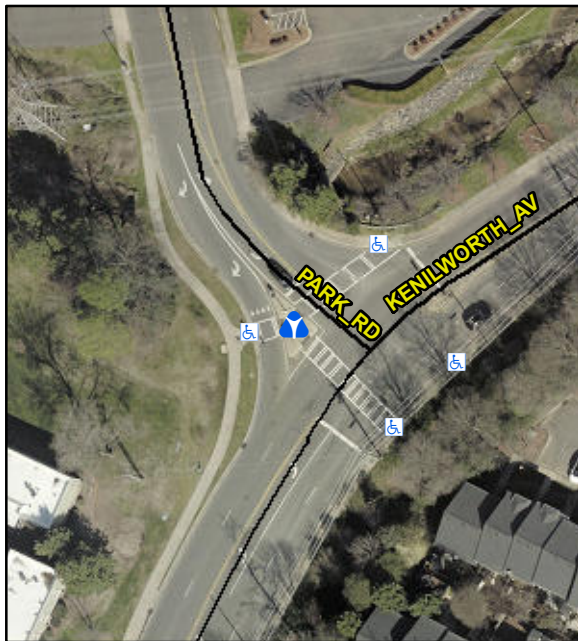
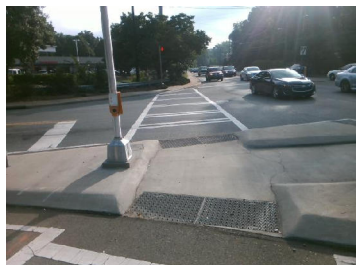
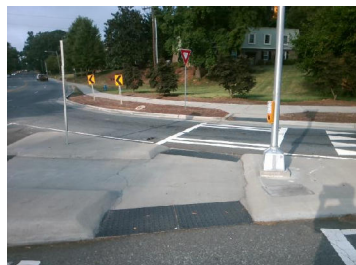
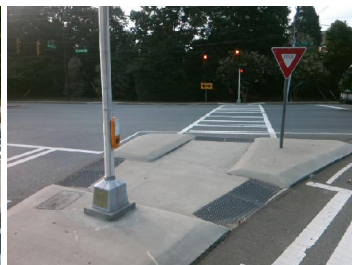
Compliance	Description	Data	Compliance	Description	Data
Yes	Refuge 1 Length (In)	47.0	N/A	Gutter 1 Ponding?	N/A
Yes	Refuge 1 Width (In)	72.0	N/A	Gutter 1 Lip Ht (In)	N/A
Yes	Refuge 1 Slope (%)	0.5	N/A	Gutter 1 Slope (%)	N/A
Yes	Refuge 1 X Slope (%)	2.7	N/A	Gutter 1 X Slope (%)	N/A
N/A	Painted X Walk1?	Yes	N/A	DWS 1 Provided?	N/A
N/A	X Walk 1 Direction	To NE	N/A	DWS 1 Contrast?	N/A
N/A	X Walk 1 Width (In)	110.0	N/A	DWS 1 Length (In)	N/A
N/A	Road 1 Slope (%)	1.4	N/A	DWS 1 Full Width?	N/A
N/A	Road 1 X Slope (%)	2.0	N/A	DWS 1 Offset (In)	N/A
Yes	Refuge 2 Length (In)	126.0	N/A	Gutter 2 Ponding?	N/A
Yes	Refuge 2 Width (In)	71.0	N/A	Gutter 2 Lip Ht (In)	N/A
Yes	Refuge 2 Slope (%)	0.7	N/A	Gutter 2 Slope (%)	N/A
Yes	Refuge 2 X Slope (%)	0.2	N/A	Gutter 2 X Slope (%)	N/A
N/A	Painted X Walk2?	Yes	N/A	DWS 2 Provided?	N/A
N/A	X Walk 2 Direction	To SE	N/A	DWS 2 Contrast?	N/A
N/A	X Walk 2 Width (In)	118.0	N/A	DWS 2 Length (In)	N/A

N/A	Road 2 Slope (%)	1.0	N/A	DWS 2 Full Width?	N/A
N/A	Road 2 X Slope (%)	0.2	N/A	DWS 2 Offset (In)	N/A
Yes	Refuge 3 Length (in)	47.0	N/A	Gutter 3 Ponding?	N/A
Yes	Refuge 3 Width (in)	72.0	N/A	Gutter 3 Lip Ht (in)	N/A
No	Refuge 3 Slope (%)	5.8	N/A	Gutter 3 Slope (%)	N/A
Yes	Refuge 3 XSlope (%)	1.4	N/A	Gutter 3 XSlope (%)	N/A
N/A	Painted X Walk3?	Yes	N/A	DWS 3 Provided?	N/A
N/A	X Walk 3 Direction	To SW	N/A	DWS 3 Contrast?	N/A
N/A	X Walk 3 Width (in)	108.0	N/A	DWS 3 Length (in)	N/A
N/A	Road 3 Slope (%)	0.3	N/A	DWS 3 Full Width?	N/A
N/A	Road 3 XSlope (%)	1.5	N/A	DWS 3 Offset (in)	N/A
Yes	Any Obstructions?	N/A	N/A	Storm Grate/Utility Hazard?	N/A
N/A	Obstruction Type		N/A	Storm Grate/Utility Type	
			N/A		N/A
N/A	Surface Condition	Good

**Remove & Replace Entire Refuge.**
