Access Compliance Report

Public Rights-of-Way

(Island Curb Cuts)

Intersection ID: 27397	Main Street: ELM_LN	Cross Street: BALLANTYNE_COMMONS_PY	Location: E
ADA ID: 16D8A42EAAF5	Curb Cut Type: MedianRefuge2	Initial Pass/Fail: Fail	Overall Compliance: No
Codes/Mitigation Info/Possible Solution		Field Measurements/Component Compliance	
Severity Score: 0

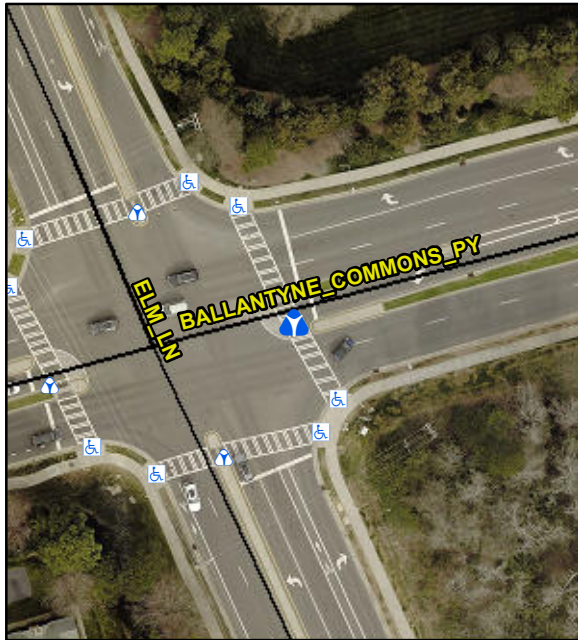
Compliance	Description	Data	Compliance	Description	Data
Yes	Refuge 1 Length (In)	48.0	N/A	Gutter 1 Ponding?	N/A
Yes	Refuge 1 Width (In)	98.0	N/A	Gutter 1 Lip Ht (In)	N/A
Yes	Refuge 1 Slope (%)	1.6	N/A	Gutter 1 Slope (%)	N/A
Yes	Refuge 1 X Slope (%)	2.8	N/A	Gutter 1 X Slope (%)	N/A
N/A	Painted X Walk1?	Yes	N/A	DWS 1 Provided?	N/A
N/A	X Walk 1 Direction	To NW	N/A	DWS 1 Contrast?	N/A
N/A	X Walk 1 Width (In)	113.0	N/A	DWS 1 Length (In)	N/A
N/A	Road 1 Slope (%)	0.8	N/A	DWS 1 Full Width?	N/A
N/A	Road 1 X Slope (%)	3.9	N/A	DWS 1 Offset (In)	N/A
Yes	Refuge 2 Length (In)	48.0	N/A	Gutter 2 Ponding?	N/A
Yes	Refuge 2 Width (In)	98.0	N/A	Gutter 2 Lip Ht (In)	N/A
Yes	Refuge 2 Slope (%)	2.0	N/A	Gutter 2 Slope (%)	N/A
Yes	Refuge 2 X Slope (%)	1.4	N/A	Gutter 2 X Slope (%)	N/A
N/A	Painted X Walk2?	Yes	N/A	DWS 2 Provided?	N/A
N/A	X Walk 2 Direction	To SE	N/A	DWS 2 Contrast?	N/A
N/A	X Walk 2 Width (In)	114.0	N/A	DWS 2 Length (In)	N/A

N/A	Road 2 Slope (%)	0.9	N/A	DWS 2 Full Width?	N/A
N/A	Road 2 X Slope (%)	0.3	N/A	DWS 2 Offset (In)	N/A
N/A	Refuge 3 Length (in)	N/A	N/A	Gutter 3 Ponding?	N/A
N/A	Refuge 3 Width (in)	N/A	N/A	Gutter 3 Lip Ht (in)	N/A
N/A	Refuge 3 Slope (%)	N/A	N/A	Gutter 3 Slope (%)	N/A
N/A	Refuge 3 XSlope (%)	N/A	N/A	Gutter 3 XSlope (%)	N/A
N/A	Painted X Walk3?	N/A	N/A	DWS 3 Provided?	N/A
N/A	X Walk 3 Direction	N/A	N/A	DWS 3 Contrast?	N/A
N/A	X Walk 3 Width (in)	N/A	N/A	DWS 3 Length (in)	N/A
N/A	Road 3 Slope (%)	N/A	N/A	DWS 3 Full Width?	N/A
N/A	Road 3 XSlope (%)	N/A	N/A	DWS 3 Offset (in)	N/A
Yes	Any Obstructions?	N/A	N/A	Storm Grate/Utility Hazard?	N/A
N/A	Obstruction Type		N/A	Storm Grate/Utility Type	
		N/A			N/A
N/A	Surface Condition	Good

Remove & Replace Entire Refuge.
