Access Compliance Report

Public Rights-of-Way

(Island Curb Cuts)

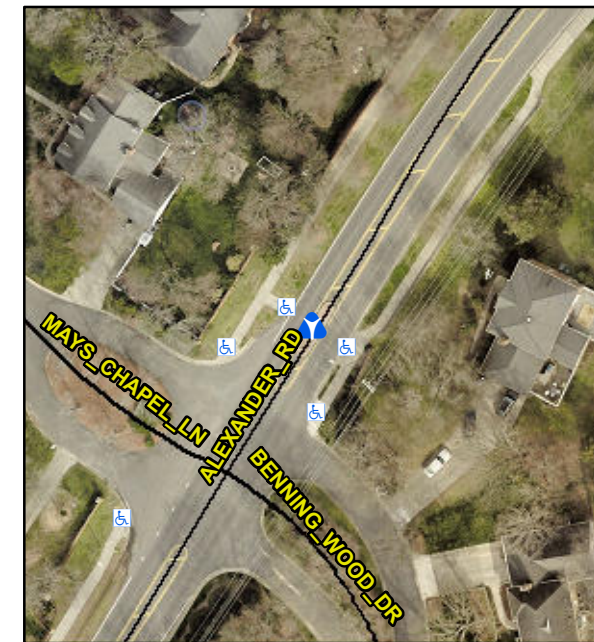
Intersection ID: 10019482	Main Street: ALEXANDER_RD	Cross Street: N/A	Location:	N/A
ADA ID: 17A1F9BAFE3E	Curb Cut Type: MedianRefuge2	Initial Pass/Fail: Pass	Overall Compliance: No	Severity Score: 0.25
Codes/Mitigation Info/Possible Solution		Field Measurements/Component Compliance

N/A	Road 2 Slope (%)	0.5	Yes	DWS 2 Full Width?	Yes
N/A	Road 2 X Slope (%)	3.9	No	DWS 2 Offset (In)	3.5
N/A	Refuge 3 Length (in)	N/A	N/A	Gutter 3 Ponding?	N/A
N/A	Refuge 3 Width (in)	N/A	N/A	Gutter 3 Lip Ht (in)	N/A
N/A	Refuge 3 Slope (%)	N/A	N/A	Gutter 3 Slope (%)	N/A
N/A	Refuge 3 XSlope (%)	N/A	N/A	Gutter 3 XSlope (%)	N/A
N/A	Painted X Walk3?	N/A	N/A	DWS 3 Provided?	N/A
N/A	X Walk 3 Direction	N/A	N/A	DWS 3 Contrast?	N/A
N/A	X Walk 3 Width (in)	N/A	N/A	DWS 3 Length (in)	N/A
N/A	Road 3 Slope (%)	N/A	N/A	DWS 3 Full Width?	N/A
N/A	Road 3 XSlope (%)	N/A	N/A	DWS 3 Offset (in)	N/A
Yes	Any Obstructions?	No	N/A	Storm Grate/Utility Hazard?	No
N/A	Obstruction Type		N/A	Storm Grate/Utility Type	
		N/A			N/A
N/A	Surface Condition	Good

Remove & Replace Detectable Warning System.
