Access Compliance Report

Public Rights-of-Way

(Island Curb Cuts)

| Intersection ID: 7025 | Main Street: HUTCHISON-MCDONALD_RD | Cross Street: STATESVILLE_RD | Location: S |

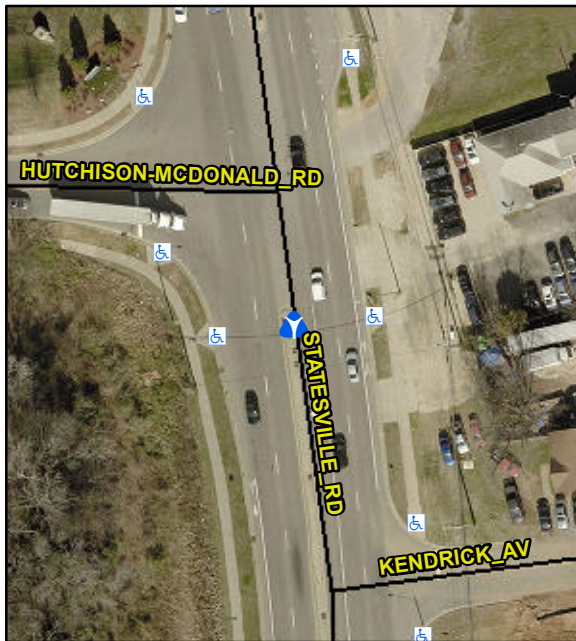
| Severity Score: 15 | | | |

| Compliance | Description | Data | Compliance | Description | Data |
|---|---|---|---|---|---|
| No | Refuge 1 Length (In) | 35.0 | No | Gutter 1 Ponding? | Yes |
| No | Refuge 2 Length (In) | 35.0 | No | Gutter 2 Ponding? | Yes |

**Remove & Replace Entire Refuge.
Fix Gutter Ponding. Grind Gutter
Lip.**

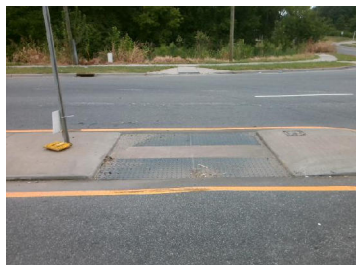
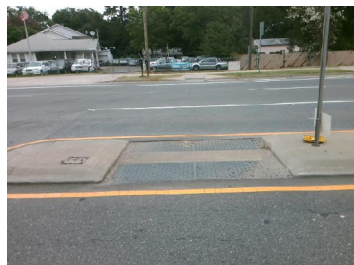
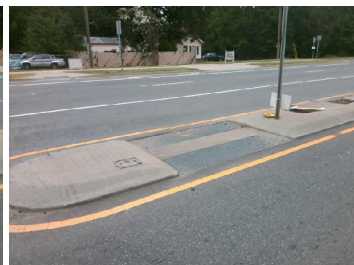
| Compliance | Description | Data | Compliance | Description | Data |
|---|---|---|---|---|---|
| Yes | Refuge 1 Width (In) | 95.0 | No | Gutter 1 Lip Ht (In) | 1.0 |
