# Access Compliance Report

## Public Rights-of-Way

### (Island Curb Cuts)

| Intersection ID: 52288 | Main Street: STEELE_CREEK_RD | Cross Street: DIXIE_RIVER_RD | Location: | S |

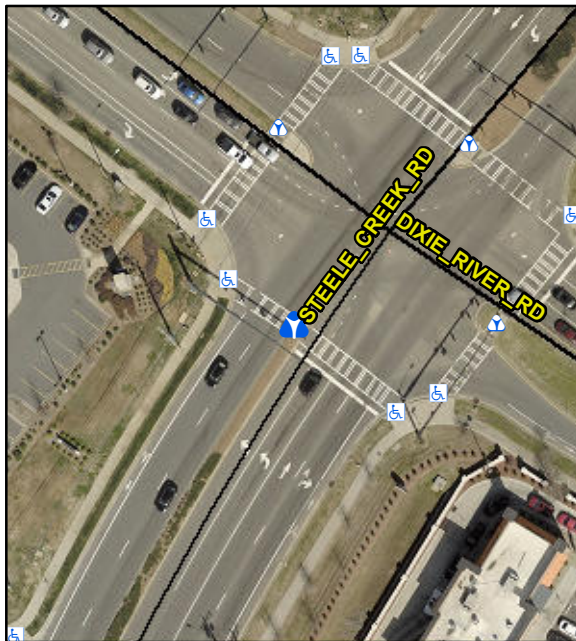
| ADA ID: 18A768134B68 | Curb Cut Type: MedianRefuge2 | Initial Pass/Fail: Pass | Overall Compliance: No | Severity Score: 10 |

| Compliance | Description | Data | Compliance | Description | Data |
|---|---|---|---|---|---|
| Yes | Refuge 1 Width (In) | 98 | No | Gutter 1 Lip Ht (In) | N.A |
| Yes | Refuge 1 Slope (%) | 2.0 | No | Gutter 1 Slope (%) | 6.6 |
| Yes | Refuge 1 X Slope (%) | 1.4 | No | Gutter 1 X Slope (%) | 2.4 |
| N/A | Road 1 X Slope (%) | 0.4 | No | DWS 1 Offset (In) | N.A |
| Yes | Refuge 2 Width (In) | 98 | No | Gutter 2 Lip Ht (In) | N.A |

**Remove & Replace Detectable Warning System. Grind Gutter Lip. Remove & Replace Gutter.**
