# Access Compliance Report

## Public Rights-of-Way

### (Island Curb Cuts)

Intersection ID: 47099	Main Street: GALLERIA_BV	Cross Street: N/A	Location: W
ADA ID: 1AD56FF0DA47	Curb Cut Type: MedianRefuge2	Initial Pass/Fail: Fail	Overall Compliance: No
Codes/Mitigation Info/Possible Solution		Field Measurements/Component Compliance

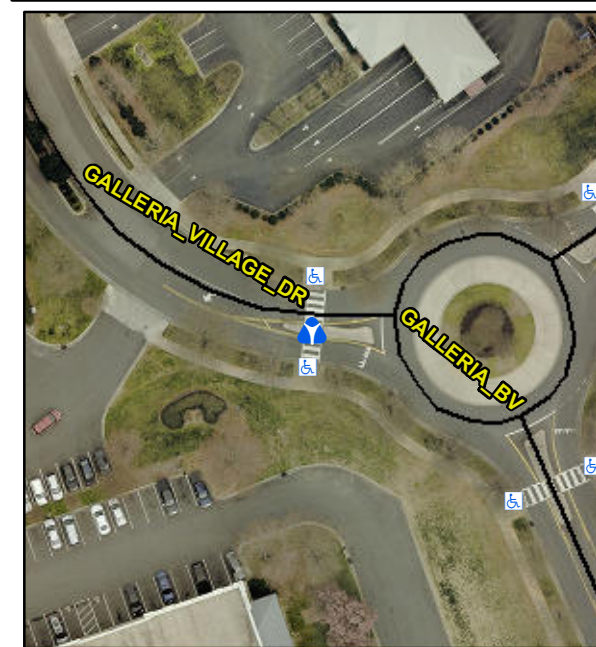
Compliance	Description	Data	Compliance	Description	Data
No	Refuge 1 Length (In)	30.0	N/A	Gutter 1 Ponding?	N/A
Yes	Refuge 1 Width (In)	120.0	N/A	Gutter 1 Lip Ht (In)	N/A
Yes	Refuge 1 Slope (%)	0.4	N/A	Gutter 1 Slope (%)	N/A
No	Refuge 1 X Slope (%)	6.4	N/A	Gutter 1 X Slope (%)	N/A
N/A	Painted X Walk1?	Yes	N/A	DWS 1 Provided?	N/A
N/A	X Walk 1 Direction	To S	N/A	DWS 1 Contrast?	N/A
N/A	X Walk 1 Width (In)	100.0	N/A	DWS 1 Length (In)	N/A
N/A	Road 1 Slope (%)	2.5	N/A	DWS 1 Full Width?	N/A
N/A	Road 1 X Slope (%)	4.7	N/A	DWS 1 Offset (In)	N/A
No	Refuge 2 Length (In)	30.0	N/A	Gutter 2 Ponding?	N/A
Yes	Refuge 2 Width (In)	120.0	N/A	Gutter 2 Lip Ht (In)	N/A
Yes	Refuge 2 Slope (%)	1.6	N/A	Gutter 2 Slope (%)	N/A
Yes	Refuge 2 X Slope (%)	0.9	N/A	Gutter 2 X Slope (%)	N/A
N/A	Painted X Walk2?	Yes	N/A	DWS 2 Provided?	N/A
N/A	X Walk 2 Direction	To N	N/A	DWS 2 Contrast?	N/A
N/A	X Walk 2 Width (In)	100.0	N/A	DWS 2 Length (In)	N/A

**Remove & Replace Entire Refuge.**
