Access Compliance Report

Public Rights-of-Way

(Island Curb Cuts)

Intersection ID: 47611	Main Street: WYALONG_DR	Cross Street: MINTWORTH_AV	Location: NE
ADA ID: 1B26A0251C47	Curb Cut Type: MedianRefuge2	Initial Pass/Fail: Fail	Overall Compliance: No
Codes/Mitigation Info/Possible Solution		Field Measurements/Component Compliance	
Severity Score: 8.75

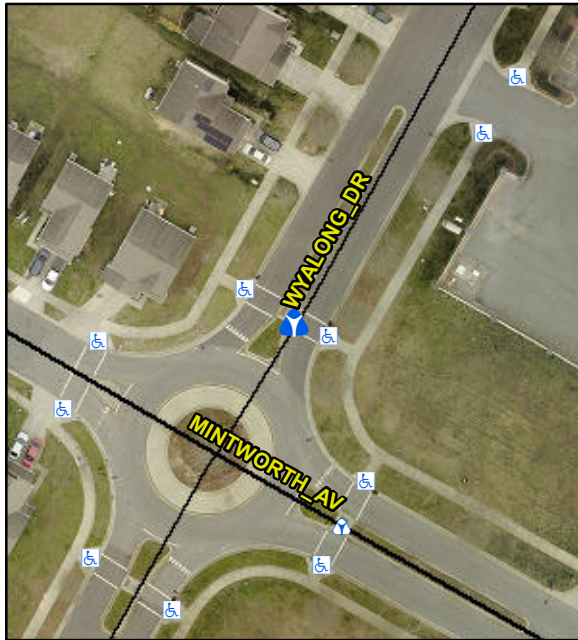
Compliance	Description	Data	Compliance	Description	Data
No	Refuge 1 Length (In)	32.5	N/A	Gutter 1 Ponding?	N/A
No	Refuge 1 Width (In)	48.0	N/A	Gutter 1 Lip Ht (In)	N/A
Yes	Refuge 1 Slope (%)	0.6	N/A	Gutter 1 Slope (%)	N/A
Yes	Refuge 1 X Slope (%)	2.6	N/A	Gutter 1 X Slope (%)	N/A
N/A	Painted X Walk1?	Yes	N/A	DWS 1 Provided?	N/A
N/A	X Walk 1 Direction	To SE	N/A	DWS 1 Contrast?	N/A
N/A	X Walk 1 Width (In)	119.0	N/A	DWS 1 Length (In)	N/A
N/A	Road 1 Slope (%)	0.4	N/A	DWS 1 Full Width?	N/A
N/A	Road 1 X Slope (%)	6.0	N/A	DWS 1 Offset (In)	N/A
No	Refuge 2 Length (In)	32.5	N/A	Gutter 2 Ponding?	N/A
No	Refuge 2 Width (In)	48.0	N/A	Gutter 2 Lip Ht (In)	N/A
Yes	Refuge 2 Slope (%)	0.0	N/A	Gutter 2 Slope (%)	N/A
Yes	Refuge 2 X Slope (%)	3.0	N/A	Gutter 2 X Slope (%)	N/A
N/A	Painted X Walk2?	Yes	N/A	DWS 2 Provided?	N/A
N/A	X Walk 2 Direction	To NW	N/A	DWS 2 Contrast?	N/A
N/A	X Walk 2 Width (In)	119.0	N/A	DWS 2 Length (In)	N/A

Possible Solutions:

Remove & Replace Entire Refuge.
