# Access Compliance Report

## Public Rights-of-Way

### (Island Curb Cuts)

Intersection ID: 10011809	Main Street: STATESVILLE_RD	Cross Street: N/A	Location: N
ADA ID: 1B36F051ED7C	Curb Cut Type: MedianRefuge2	Initial Pass/Fail: Pass	Overall Compliance: No
		Severity Score: 0

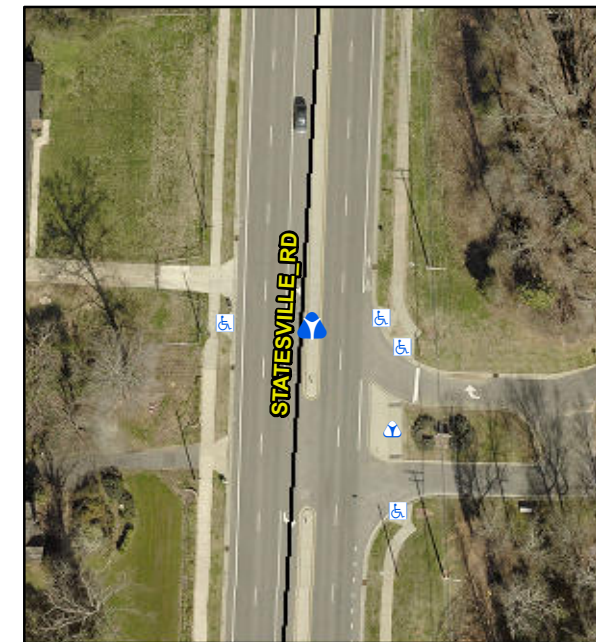
Compliance	Description	Data	Compliance	Description	Data
Yes	Refuge 1 Length (In)	36.5	Yes	Gutter 1 Ponding?	No
Yes	Refuge 1 Width (In)	96.0	No	Gutter 1 Lip Ht (In)	0.25
Yes	Refuge 1 Slope (%)	1.5	Yes	Gutter 1 Slope (%)	2.1
Yes	Refuge 1 X Slope (%)	0.0	Yes	Gutter 1 X Slope (%)	0.8
N/A	Painted X Walk1?	No	Yes	DWS 1 Provided?	Yes
N/A	X Walk 1 Direction	To E	Yes	DWS 1 Contrast?	Yes
N/A	X Walk 1 Width (In)	N/A	Yes	DWS 1 Length (In)	24.0
N/A	Road 1 Slope (%)	0.6	Yes	DWS 1 Full Width?	Yes
N/A	Road 1 X Slope (%)	1.7	Yes	DWS 1 Offset (In)	0.0
Yes	Refuge 2 Length (In)	36.5	Yes	Gutter 2 Ponding?	No
Yes	Refuge 2 Width (In)	96.0	No	Gutter 2 Lip Ht (In)	0.25
Yes	Refuge 2 Slope (%)	1.0	Yes	Gutter 2 Slope (%)	1.9
Yes	Refuge 2 X Slope (%)	0.3	Yes	Gutter 2 X Slope (%)	0.0
N/A	Painted X Walk2?	No	Yes	DWS 2 Provided?	Yes
N/A	X Walk 2 Direction	To W	Yes	DWS 2 Contrast?	Yes
N/A	X Walk 2 Width (In)	N/A	Yes	DWS 2 Length (In)	24.0

N/A	Road 2 Slope (%)	0.2	Yes	DWS 2 Full Width?	Yes
N/A	Road 2 X Slope (%)	2.2	Yes	DWS 2 Offset (In)	0.0
N/A	Refuge 3 Length (in)	N/A	N/A	Gutter 3 Ponding?	No
N/A	Refuge 3 Width (in)	N/A	N/A	Gutter 3 Lip Ht (in)	N/A
N/A	Refuge 3 Slope (%)	N/A	N/A	Gutter 3 Slope (%)	N/A
N/A	Refuge 3 XSlope (%)	N/A	N/A	Gutter 3 XSlope (%)	N/A
N/A	Painted X Walk3?	No	N/A	DWS 3 Provided?	N/A
N/A	X Walk 3 Direction	N/A	N/A	DWS 3 Contrast?	N/A
N/A	X Walk 3 Width (in)	N/A	N/A	DWS 3 Length (in)	N/A
N/A	Road 3 Slope (%)	N/A	N/A	DWS 3 Full Width?	N/A
N/A	Road 3 XSlope (%)	N/A	N/A	DWS 3 Offset (in)	N/A
Yes	Any Obstructions?	No	N/A	Storm Grate/Utility Hazard?	No
N/A	Obstruction Type		N/A	Storm Grate/Utility Type	
		N/A			N/A
N/A	Surface Condition	Good

**Grind Gutter Lip.**

**\$ 400.00**
