Access Compliance Report

Public Rights-of-Way

(Island Curb Cuts)

Intersection ID: 10025398	Main Street: E_ARROWWOOD_RD	Cross Street: N/A	Location: E
ADA ID: 1B3D52129F1D	Curb Cut Type: MedianRefuge2	Initial Pass/Fail: Fail	Overall Compliance: No
Codes/Mitigation Info/Possible Solution		Field Measurements/Component Compliance

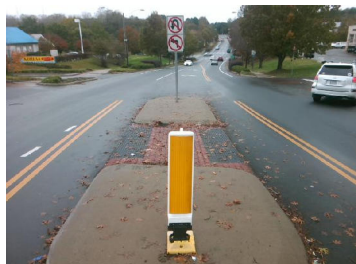
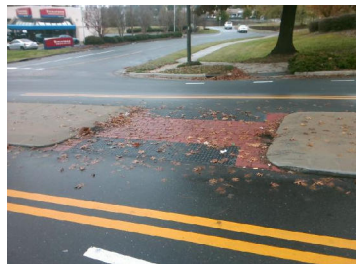
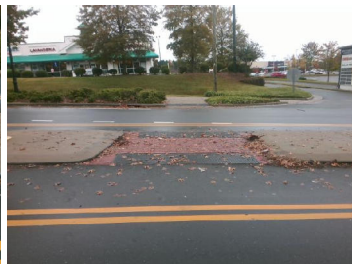
Compliance	Description	Data	Compliance	Description	Data
Yes	Refuge 1 Length (In)	48.0	N/A	Gutter 1 Ponding?	N/A
Yes	Refuge 1 Width (In)	119.0	N/A	Gutter 1 Lip Ht (In)	N/A
Yes	Refuge 1 Slope (%)	1.5	N/A	Gutter 1 Slope (%)	N/A
No	Refuge 1 X Slope (%)	6.5	N/A	Gutter 1 X Slope (%)	N/A
N/A	Painted X Walk1?	No	N/A	DWS 1 Provided?	N/A
N/A	X Walk 1 Direction	To N	N/A	DWS 1 Contrast?	N/A
N/A	X Walk 1 Width (In)	N/A	N/A	DWS 1 Length (In)	N/A
N/A	Road 1 Slope (%)	7.9	N/A	DWS 1 Full Width?	N/A
N/A	Road 1 X Slope (%)	4.0	N/A	DWS 1 Offset (In)	N/A
Yes	Refuge 2 Length (In)	48.0	N/A	Gutter 2 Ponding?	N/A
Yes	Refuge 2 Width (In)	119.0	N/A	Gutter 2 Lip Ht (In)	N/A
Yes	Refuge 2 Slope (%)	0.8	N/A	Gutter 2 Slope (%)	N/A
No	Refuge 2 X Slope (%)	8.3	N/A	Gutter 2 X Slope (%)	N/A
N/A	Painted X Walk2?	No	N/A	DWS 2 Provided?	N/A
N/A	X Walk 2 Direction	To S	N/A	DWS 2 Contrast?	N/A
N/A	X Walk 2 Width (In)	N/A	N/A	DWS 2 Length (In)	N/A

Remove & Replace Entire Refuge.

\$ 3000.00
