Access Compliance Report

Public Rights-of-Way

(Island Curb Cuts)

Intersection ID: 6370	Main Street: LAKE_RD	Cross Street: MILHAVEN_LN	Location: S
ADA ID: 1B4B9ADBDA9D	Curb Cut Type: MedianRefuge2	Initial Pass/Fail: Pass	Overall Compliance: No
Severity Score: 0.25			
Codes/Mitigation Info/Possible Solution		Field Measurements/Component Compliance

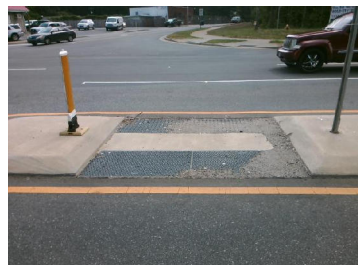
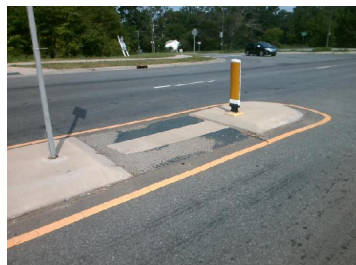
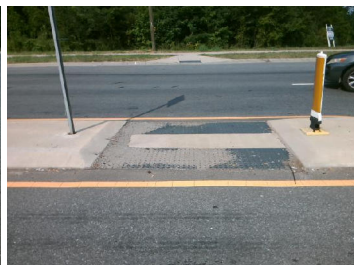
Compliance	Description	Data	Compliance	Description	Data
Yes	Refuge 1 Length (In)	36.0	No	Gutter 1 Ponding?	Yes
Yes	Refuge 1 Width (In)	96.0	No	Gutter 1 Lip Ht (In)	0.25
Yes	Refuge 1 Slope (%)	3.5	Yes	Gutter 1 Slope (%)	2.4
Yes	Refuge 1 X Slope (%)	1.2	Yes	Gutter 1 X Slope (%)	0.4
N/A	Painted X Walk1?	No	Yes	DWS 1 Provided?	Yes
N/A	X Walk 1 Direction	To SW	Yes	DWS 1 Contrast?	Yes
N/A	X Walk 1 Width (In)	N/A	Yes	DWS 1 Length (In)	24.0
N/A	Road 1 Slope (%)	0.8	Yes	DWS 1 Full Width?	Yes
N/A	Road 1 X Slope (%)	3.1	Yes	DWS 1 Offset (In)	0.0
Yes	Refuge 2 Length (In)	36.0	No	Gutter 2 Ponding?	Yes
Yes	Refuge 2 Width (In)	96.0	No	Gutter 2 Lip Ht (In)	0.25
Yes	Refuge 2 Slope (%)	0.7	Yes	Gutter 2 Slope (%)	2.2
Yes	Refuge 2 X Slope (%)	1.4	Yes	Gutter 2 X Slope (%)	1.4
N/A	Painted X Walk2?	No	Yes	DWS 2 Provided?	Yes
N/A	X Walk 2 Direction	To E	Yes	DWS 2 Contrast?	Yes
N/A	X Walk 2 Width (In)	N/A	Yes	DWS 2 Length (In)	24.0

N/A	Road 2 Slope (%)	1.9	Yes	DWS 2 Full Width?	Yes
N/A	Road 2 X Slope (%)	1.9	Yes	DWS 2 Offset (In)	0.0
N/A	Refuge 3 Length (in)	N/A	N/A	Gutter 3 Ponding?	No
N/A	Refuge 3 Width (in)	N/A	N/A	Gutter 3 Lip Ht (in)	N/A
N/A	Refuge 3 Slope (%)	N/A	N/A	Gutter 3 Slope (%)	N/A
N/A	Refuge 3 XSlope (%)	N/A	N/A	Gutter 3 XSlope (%)	N/A
N/A	Painted X Walk3?	No	N/A	DWS 3 Provided?	N/A
N/A	X Walk 3 Direction	N/A	N/A	DWS 3 Contrast?	N/A
N/A	X Walk 3 Width (in)	N/A	N/A	DWS 3 Length (in)	N/A
N/A	Road 3 Slope (%)	N/A	N/A	DWS 3 Full Width?	N/A
N/A	Road 3 XSlope (%)	N/A	N/A	DWS 3 Offset (in)	N/A
Yes	Any Obstructions?	No	N/A	Storm Grate/Utility Hazard?	No
N/A	Obstruction Type		N/A	Storm Grate/Utility Type	
		N/A			N/A
N/A	Surface Condition	Good

Grind Gutter Lip.
