Access Compliance Report

Public Rights-of-Way

(Island Curb Cuts)

Intersection ID: 3276	Main Street: LAKE_SPRING_AV	Cross Street: W_W_T_HARRIS_BV	Location: SW
ADA ID: 1B6E5977B007	Curb Cut Type: MedianRefuge2	Initial Pass/Fail: Pass	Overall Compliance: No
Severity Score: 0.25			
Codes/Mitigation Info/Possible Solution		Field Measurements/Component Compliance

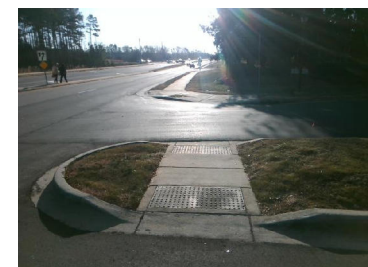
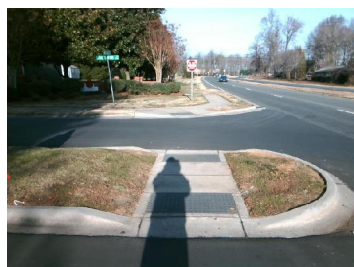
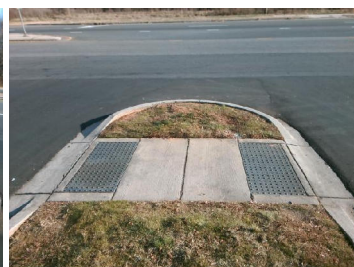
N/A	Road 2 Slope (%)	0.5	Yes	DWS 2 Full Width?	Yes
N/A	Road 2 X Slope (%)	1.6	No	DWS 2 Offset (In)	4.0
N/A	Refuge 3 Length (in)	N/A	N/A	Gutter 3 Ponding?	N/A
N/A	Refuge 3 Width (in)	N/A	N/A	Gutter 3 Lip Ht (in)	N/A
N/A	Refuge 3 Slope (%)	N/A	N/A	Gutter 3 Slope (%)	N/A
N/A	Refuge 3 XSlope (%)	N/A	N/A	Gutter 3 XSlope (%)	N/A
N/A	Painted X Walk3?	N/A	N/A	DWS 3 Provided?	N/A
N/A	X Walk 3 Direction	N/A	N/A	DWS 3 Contrast?	N/A
N/A	X Walk 3 Width (in)	N/A	N/A	DWS 3 Length (in)	N/A
N/A	Road 3 Slope (%)	N/A	N/A	DWS 3 Full Width?	N/A
N/A	Road 3 XSlope (%)	N/A	N/A	DWS 3 Offset (in)	N/A
Yes	Any Obstructions?	No	N/A	Storm Grate/Utility Hazard?	No
N/A	Obstruction Type		N/A	Storm Grate/Utility Type	
		N/A			N/A
N/A	Surface Condition	Good

Possible Solutions:

Remove & Replace Detectable Warning System.
