Access Compliance Report

Public Rights-of-Way

(Island Curb Cuts)

Intersection ID: 10038340	Main Street: SOUTH_BV	Cross Street: N/A	Location: S
ADA ID: 1C39A1E43F81	Curb Cut Type: MedianRefuge2	Initial Pass/Fail: Fail	Overall Compliance: No
Codes/Mitigation Info/Possible Solution		Field Measurements/Component Compliance

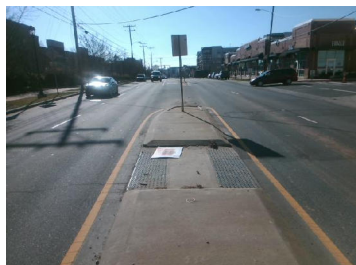
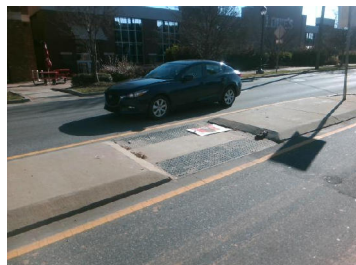
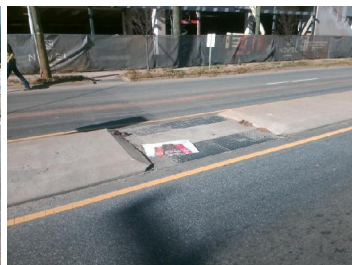
Compliance	Description	Data	Compliance	Description	Data
No	Refuge 1 Length (In)	31.0	N/A	Gutter 1 Ponding?	N/A
Yes	Refuge 1 Width (In)	98.0	N/A	Gutter 1 Lip Ht (In)	N/A
Yes	Refuge 1 Slope (%)	1.2	N/A	Gutter 1 Slope (%)	N/A
Yes	Refuge 1 X Slope (%)	2.6	N/A	Gutter 1 X Slope (%)	N/A
N/A	Painted X Walk1?	No	N/A	DWS 1 Provided?	N/A
N/A	X Walk 1 Direction	To SE	N/A	DWS 1 Contrast?	N/A
N/A	X Walk 1 Width (In)	N/A	N/A	DWS 1 Length (In)	N/A
N/A	Road 1 Slope (%)	2.8	N/A	DWS 1 Full Width?	N/A
N/A	Road 1 X Slope (%)	2.2	N/A	DWS 1 Offset (In)	N/A
No	Refuge 2 Length (In)	31.0	N/A	Gutter 2 Ponding?	N/A
Yes	Refuge 2 Width (In)	98.0	N/A	Gutter 2 Lip Ht (In)	N/A
Yes	Refuge 2 Slope (%)	4.0	N/A	Gutter 2 Slope (%)	N/A
Yes	Refuge 2 X Slope (%)	1.0	N/A	Gutter 2 X Slope (%)	N/A
N/A	Painted X Walk2?	No	N/A	DWS 2 Provided?	N/A
N/A	X Walk 2 Direction	To NW	N/A	DWS 2 Contrast?	N/A
N/A	X Walk 2 Width (In)	N/A	N/A	DWS 2 Length (In)	N/A

N/A	Road 2 Slope (%)	0.6	N/A	DWS 2 Full Width?	N/A
N/A	Road 2 X Slope (%)	2.7	N/A	DWS 2 Offset (In)	N/A
N/A	Refuge 3 Length (in)	N/A	N/A	Gutter 3 Ponding?	N/A
N/A	Refuge 3 Width (in)	N/A	N/A	Gutter 3 Lip Ht (in)	N/A
N/A	Refuge 3 Slope (%)	N/A	N/A	Gutter 3 Slope (%)	N/A
N/A	Refuge 3 XSlope (%)	N/A	N/A	Gutter 3 XSlope (%)	N/A
N/A	Painted X Walk3?	N/A	N/A	DWS 3 Provided?	N/A
N/A	X Walk 3 Direction	N/A	N/A	DWS 3 Contrast?	N/A
N/A	X Walk 3 Width (in)	N/A	N/A	DWS 3 Length (in)	N/A
N/A	Road 3 Slope (%)	N/A	N/A	DWS 3 Full Width?	N/A
N/A	Road 3 XSlope (%)	N/A	N/A	DWS 3 Offset (in)	N/A
Yes	Any Obstructions?	N/A	N/A	Storm Grate/Utility Hazard?	N/A
N/A	Obstruction Type		N/A	Storm Grate/Utility Type	
		N/A			N/A
N/A	Surface Condition	Good

Remove & Replace Entire Refuge.
