Access Compliance Report

Public Rights-of-Way

(Island Curb Cuts)

Intersection ID: 10390	Main Street: ENDERLY_RD	Cross Street: TUCKASEEGEE_RD	Location: S
ADA ID: 1C74069F13D5	Curb Cut Type: MedianRefuge2	Initial Pass/Fail: Fail	Overall Compliance: No
Codes/Mitigation Info/Possible Solution		Field Measurements/Component Compliance	
Severity Score: 25

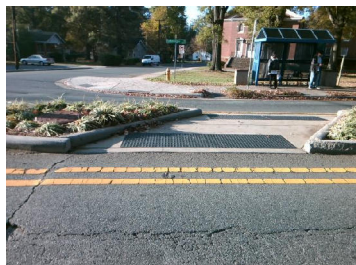
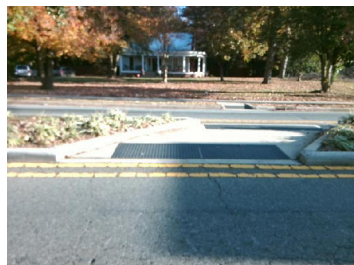
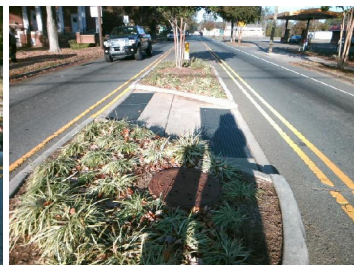
Compliance	Description	Data	Compliance	Description	Data
Yes	Refuge 1 Length (In)	61.0	N/A	Gutter 1 Ponding?	N/A
Yes	Refuge 1 Width (In)	124.0	N/A	Gutter 1 Lip Ht (In)	N/A
No	Refuge 1 Slope (%)	8.8	N/A	Gutter 1 Slope (%)	N/A
Yes	Refuge 1 X Slope (%)	1.0	N/A	Gutter 1 X Slope (%)	N/A
N/A	Painted X Walk1?	No	N/A	DWS 1 Provided?	N/A
N/A	X Walk 1 Direction	To S	N/A	DWS 1 Contrast?	N/A
N/A	X Walk 1 Width (In)	N/A	N/A	DWS 1 Length (In)	N/A
N/A	Road 1 Slope (%)	0.1	N/A	DWS 1 Full Width?	N/A
N/A	Road 1 X Slope (%)	9.1	N/A	DWS 1 Offset (In)	N/A
Yes	Refuge 2 Length (In)	61.0	N/A	Gutter 2 Ponding?	N/A
Yes	Refuge 2 Width (In)	124.0	N/A	Gutter 2 Lip Ht (In)	N/A
Yes	Refuge 2 Slope (%)	1.6	N/A	Gutter 2 Slope (%)	N/A
Yes	Refuge 2 X Slope (%)	0.2	N/A	Gutter 2 X Slope (%)	N/A
N/A	Painted X Walk2?	No	N/A	DWS 2 Provided?	N/A
N/A	X Walk 2 Direction	To N	N/A	DWS 2 Contrast?	N/A
N/A	X Walk 2 Width (In)	N/A	N/A	DWS 2 Length (In)	N/A

N/A	Road 2 Slope (%)	0.1	N/A	DWS 2 Full Width?	N/A
N/A	Road 2 X Slope (%)	4.6	N/A	DWS 2 Offset (In)	N/A
N/A	Refuge 3 Length (in)	N/A	N/A	Gutter 3 Ponding?	N/A
N/A	Refuge 3 Width (in)	N/A	N/A	Gutter 3 Lip Ht (in)	N/A
N/A	Refuge 3 Slope (%)	N/A	N/A	Gutter 3 Slope (%)	N/A
N/A	Refuge 3 XSlope (%)	N/A	N/A	Gutter 3 XSlope (%)	N/A
N/A	Painted X Walk3?	N/A	N/A	DWS 3 Provided?	N/A
N/A	X Walk 3 Direction	N/A	N/A	DWS 3 Contrast?	N/A
N/A	X Walk 3 Width (in)	N/A	N/A	DWS 3 Length (in)	N/A
N/A	Road 3 Slope (%)	N/A	N/A	DWS 3 Full Width?	N/A
N/A	Road 3 XSlope (%)	N/A	N/A	DWS 3 Offset (in)	N/A
Yes	Any Obstructions?	N/A	N/A	Storm Grate/Utility Hazard?	N/A
N/A	Obstruction Type		N/A	Storm Grate/Utility Type	
		N/A			N/A
N/A	Surface Condition	Good

Remove & Replace Entire Refuge.
