Access Compliance Report

Public Rights-of-Way

(Island Curb Cuts)

Intersection ID: 5889	Main Street: UNIVERSITY_CITY_BV	Cross Street: SUTHER_RD	Location: E
ADA ID: 1D96EB79EBAA	Curb Cut Type: MedianRefuge2	Initial Pass/Fail: Fail	Overall Compliance: No
Codes/Mitigation Info/Possible Solution		Field Measurements/Component Compliance	
Severity Score: 25

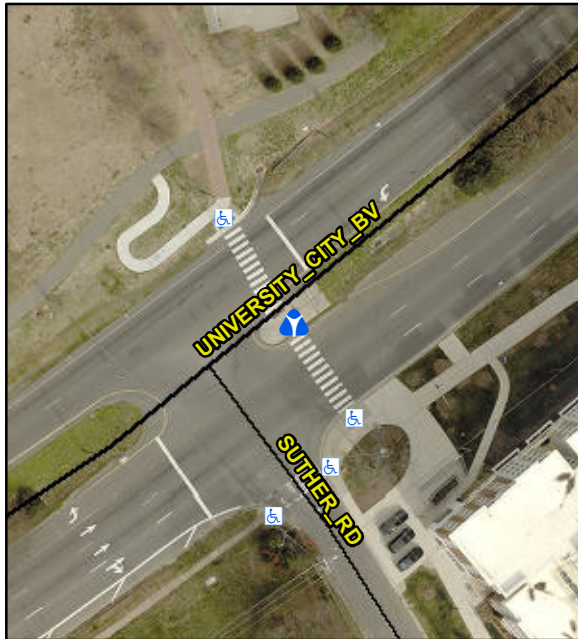
Compliance	Description	Data	Compliance	Description	Data
Yes	Refuge 1 Length (In)	75.5	N/A	Gutter 1 Ponding?	N/A
Yes	Refuge 1 Width (In)	96.0	N/A	Gutter 1 Lip Ht (In)	N/A
No	Refuge 1 Slope (%)	13.5	N/A	Gutter 1 Slope (%)	N/A
Yes	Refuge 1 X Slope (%)	0.3	N/A	Gutter 1 X Slope (%)	N/A
N/A	Painted X Walk1?	Yes	N/A	DWS 1 Provided?	N/A
N/A	X Walk 1 Direction	To NW	N/A	DWS 1 Contrast?	N/A
N/A	X Walk 1 Width (In)	125.0	N/A	DWS 1 Length (In)	N/A
N/A	Road 1 Slope (%)	1.3	N/A	DWS 1 Full Width?	N/A
N/A	Road 1 X Slope (%)	3.3	N/A	DWS 1 Offset (In)	N/A
Yes	Refuge 2 Length (In)	75.5	N/A	Gutter 2 Ponding?	N/A
Yes	Refuge 2 Width (In)	96.0	N/A	Gutter 2 Lip Ht (In)	N/A
No	Refuge 2 Slope (%)	18.0	N/A	Gutter 2 Slope (%)	N/A
Yes	Refuge 2 X Slope (%)	0.5	N/A	Gutter 2 X Slope (%)	N/A
N/A	Painted X Walk2?	Yes	N/A	DWS 2 Provided?	N/A
N/A	X Walk 2 Direction	To SE	N/A	DWS 2 Contrast?	N/A
N/A	X Walk 2 Width (In)	122.0	N/A	DWS 2 Length (In)	N/A

Possible Solutions:

Remove & Replace Entire Refuge.

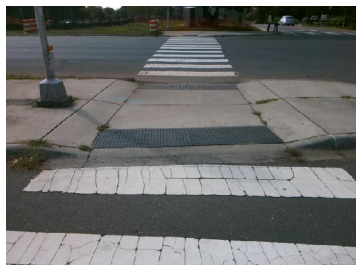
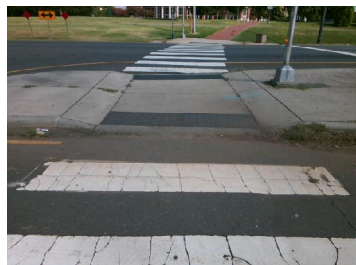
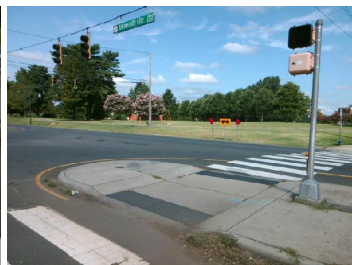
N/A	Road 2 Slope (%)	0.1	N/A	DWS 2 Full Width?	N/A
N/A	Road 2 X Slope (%)	3.8	N/A	DWS 2 Offset (In)	N/A
N/A	Refuge 3 Length (in)	N/A	N/A	Gutter 3 Ponding?	N/A
N/A	Refuge 3 Width (in)	N/A	N/A	Gutter 3 Lip Ht (in)	N/A
N/A	Refuge 3 Slope (%)	N/A	N/A	Gutter 3 Slope (%)	N/A
N/A	Refuge 3 XSlope (%)	N/A	N/A	Gutter 3 XSlope (%)	N/A
N/A	Painted X Walk3?	No	N/A	DWS 3 Provided?	N/A
N/A	X Walk 3 Direction	N/A	N/A	DWS 3 Contrast?	N/A
N/A	X Walk 3 Width (in)	N/A	N/A	DWS 3 Length (in)	N/A
N/A	Road 3 Slope (%)	N/A	N/A	DWS 3 Full Width?	N/A
N/A	Road 3 XSlope (%)	N/A	N/A	DWS 3 Offset (in)	N/A
Yes	Any Obstructions?	N/A	N/A	Storm Grate/Utility Hazard?	N/A
N/A	Obstruction Type		N/A	Storm Grate/Utility Type	
		N/A			N/A
N/A	Surface Condition	Good
