# Access Compliance Report

## Public Rights-of-Way

### (Island Curb Cuts)

Intersection ID: 14011	Main Street: WEST_BV	Cross Street: ROMARE_BEARDEN_DR	Location:	W
ADA ID: 1EE26CE13511	Curb Cut Type: MedianRefuge2	Initial Pass/Fail: Pass	Overall Compliance: No	Severity Score: 5
Codes/Mitigation Info/Possible Solution		Field Measurements/Component Compliance

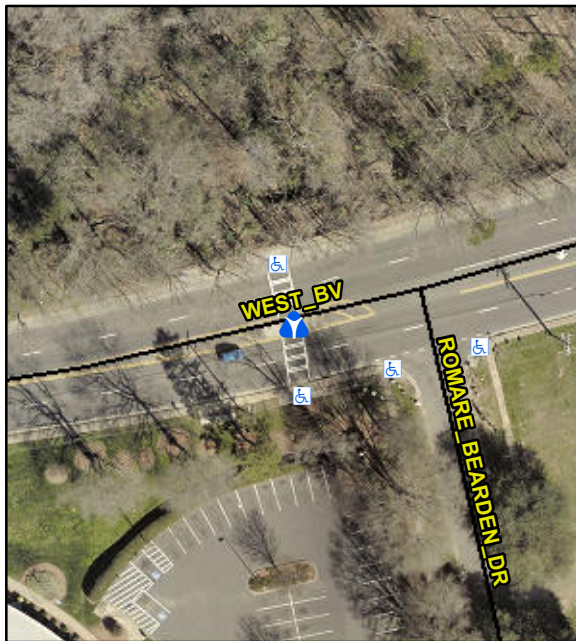
Compliance	Description	Data	Compliance	Description	Data
Yes	Refuge 1 Length (In)	48.5	Yes	Gutter 1 Ponding?	No
Yes	Refuge 1 Width (In)	118.0	Yes	Gutter 1 Lip Ht (In)	0.0
Yes	Refuge 1 Slope (%)	1.7	Yes	Gutter 1 Slope (%)	2.6
Yes	Refuge 1 X Slope (%)	1.7	Yes	Gutter 1 X Slope (%)	1.4
N/A	Painted X Walk1?	Yes	Yes	DWS 1 Provided?	Yes
N/A	X Walk 1 Direction	To N	Yes	DWS 1 Contrast?	Yes
N/A	X Walk 1 Width (In)	119.0	Yes	DWS 1 Length (In)	24.0
N/A	Road 1 Slope (%)	1.5	No	DWS 1 Full Width?	No
N/A	Road 1 X Slope (%)	1.7	No	DWS 1 Offset (In)	4.0
Yes	Refuge 2 Length (In)	48.5	Yes	Gutter 2 Ponding?	No
Yes	Refuge 2 Width (In)	118.0	Yes	Gutter 2 Lip Ht (In)	0.0
Yes	Refuge 2 Slope (%)	1.9	Yes	Gutter 2 Slope (%)	2.3
Yes	Refuge 2 X Slope (%)	1.2	Yes	Gutter 2 X Slope (%)	0.6
N/A	Painted X Walk2?	Yes	Yes	DWS 2 Provided?	Yes
N/A	X Walk 2 Direction	To S	Yes	DWS 2 Contrast?	Yes
N/A	X Walk 2 Width (In)	120.0	Yes	DWS 2 Length (In)	24.0

N/A	Road 2 Slope (%)	0.7	No	DWS 2 Full Width?	No
N/A	Road 2 X Slope (%)	1.4	No	DWS 2 Offset (In)	4.0
N/A	Refuge 3 Length (in)	N/A	N/A	Gutter 3 Ponding?	N/A
N/A	Refuge 3 Width (in)	N/A	N/A	Gutter 3 Lip Ht (in)	N/A
N/A	Refuge 3 Slope (%)	N/A	N/A	Gutter 3 Slope (%)	N/A
N/A	Refuge 3 XSlope (%)	N/A	N/A	Gutter 3 XSlope (%)	N/A
N/A	Painted X Walk3?	N/A	N/A	DWS 3 Provided?	N/A
N/A	X Walk 3 Direction	N/A	N/A	DWS 3 Contrast?	N/A
N/A	X Walk 3 Width (in)	N/A	N/A	DWS 3 Length (in)	N/A
N/A	Road 3 Slope (%)	N/A	N/A	DWS 3 Full Width?	N/A
N/A	Road 3 XSlope (%)	N/A	N/A	DWS 3 Offset (in)	N/A
Yes	Any Obstructions?	N/A	N/A	Storm Grate/Utility Hazard?	No
N/A	Obstruction Type		N/A	Storm Grate/Utility Type	
		N/A			N/A
N/A	Surface Condition	Good

**Remove & Replace Detectable Warning System.**
